GEOMORPHIC ASSESSMENT

**Fountain Creek in Woodland Park between
Aspen Garden Road and Crystola Road**

Submitted By: Golder Associates Inc.
44 Union Boulevard, Suite 300
Lakewood, Colorado 80228

June 29, 2015

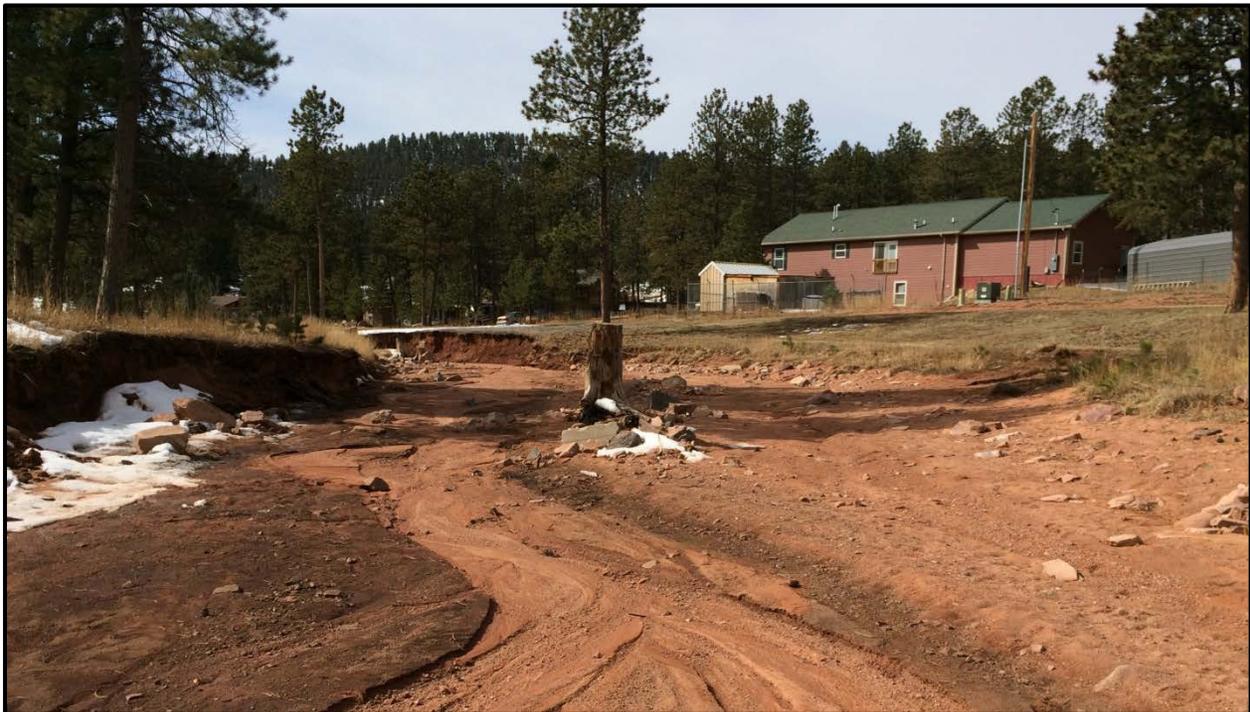
Note: The tree stump in the middle of the channel defined the former river-right bank.

Figure 3 Reach Immediately Upstream of the Study Reach; View Looking Downstream, Behind Safeway

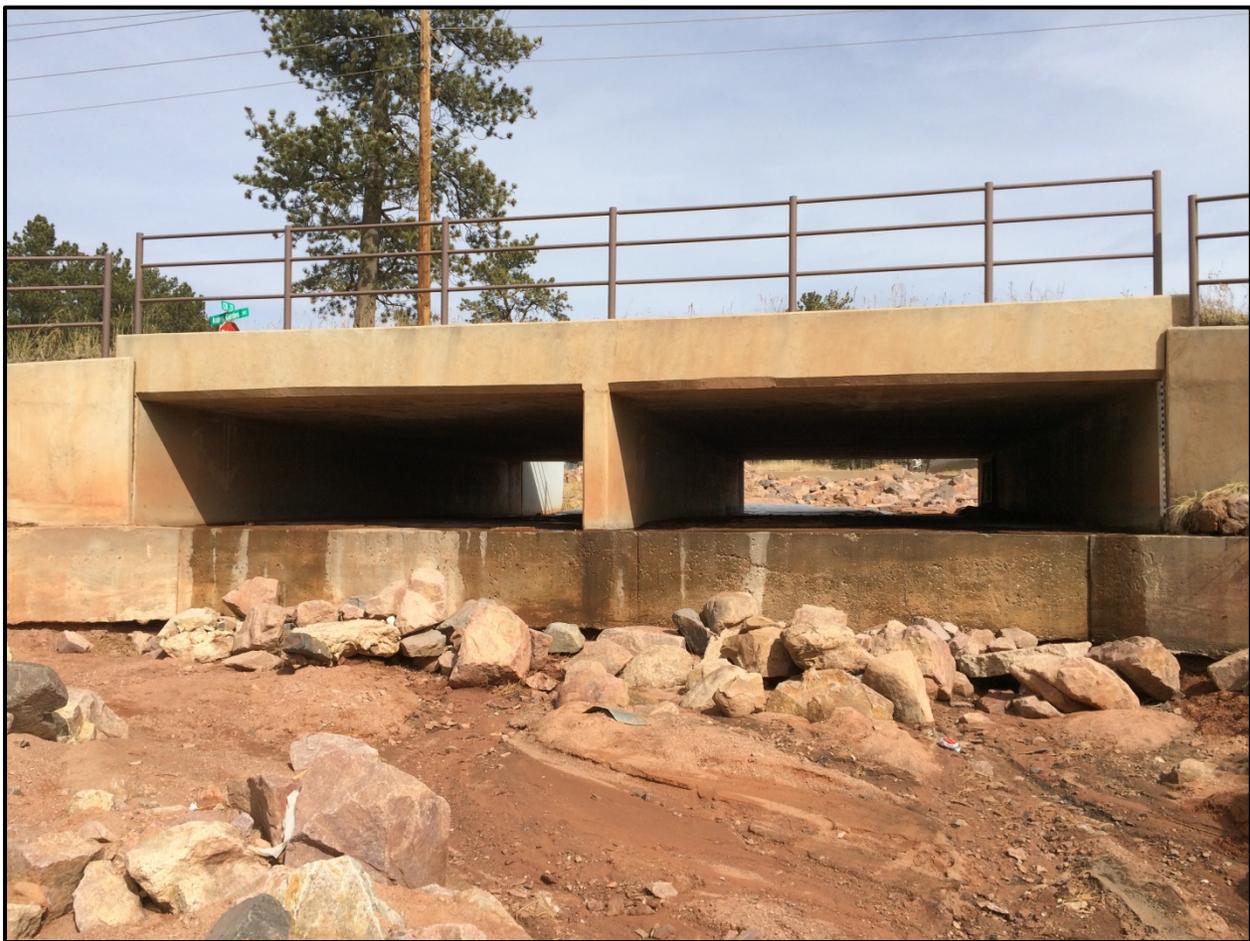
Generally the reach downstream from the bridge at Aspen garden Road, termed the Concrete Plant Reach is the most highly impacted within the Study Reach. The channel is highly armored with large riprap, poured concrete, and other construction debris. The bridge at the upstream end of the Study Reach on Aspen Garden Road serves as a point of flow constriction and a grade control structure. The relatively shallow and narrow passage under the bridge will be suitable for most flow conditions, but will likely result in over topping and bypass flow in high magnitude discharge events. The grade control function of the bridge is functioning as intended, however the downstream foundation of the bridge is being undercut (see Figure 4).

Figure 4 Undercutting of Aspen Garden Bridge on the Downstream Side

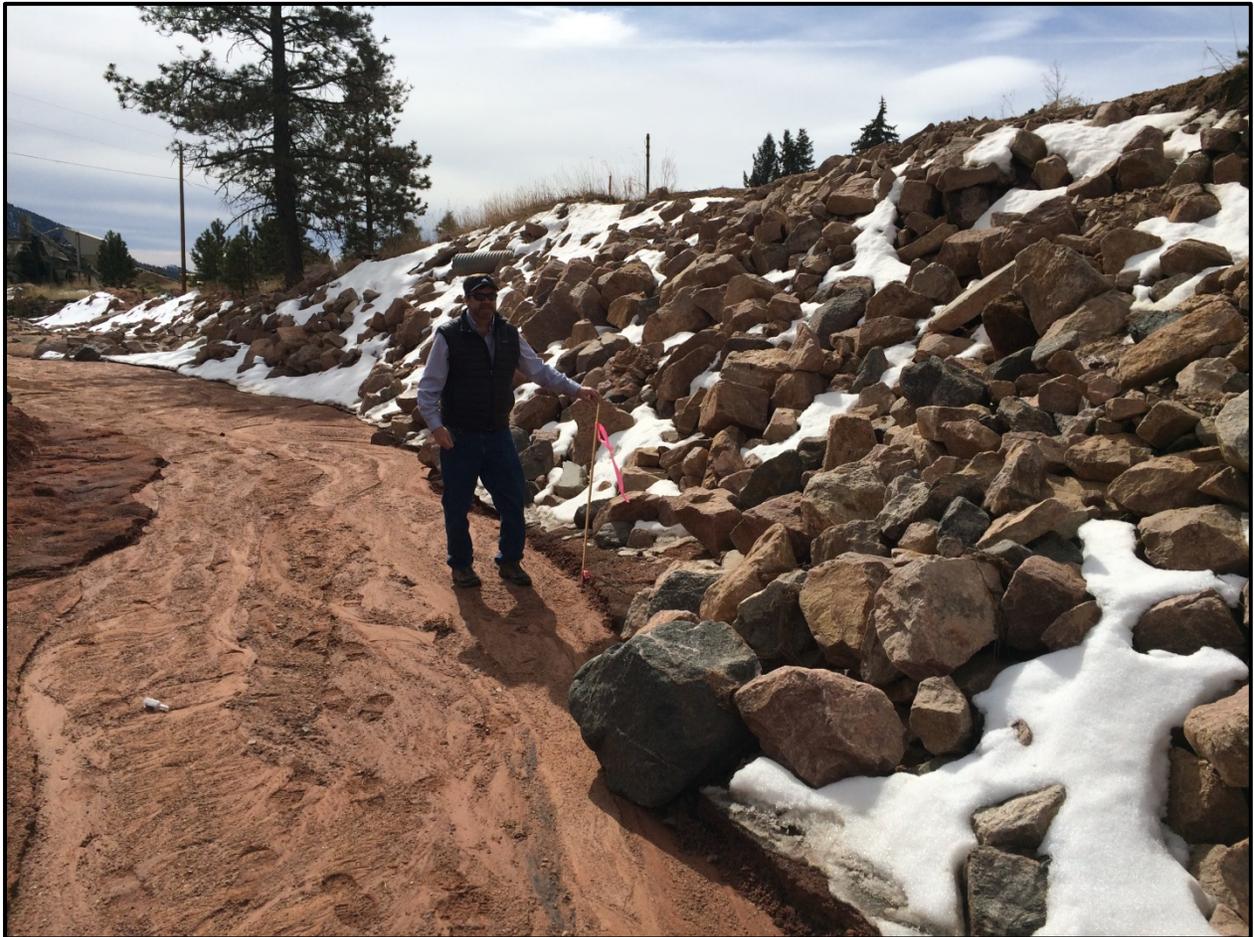
Figure 5 Right-of-Way Marker at Toe of Bank Downstream from Aspen Garden Bridge; View Looking Downstream

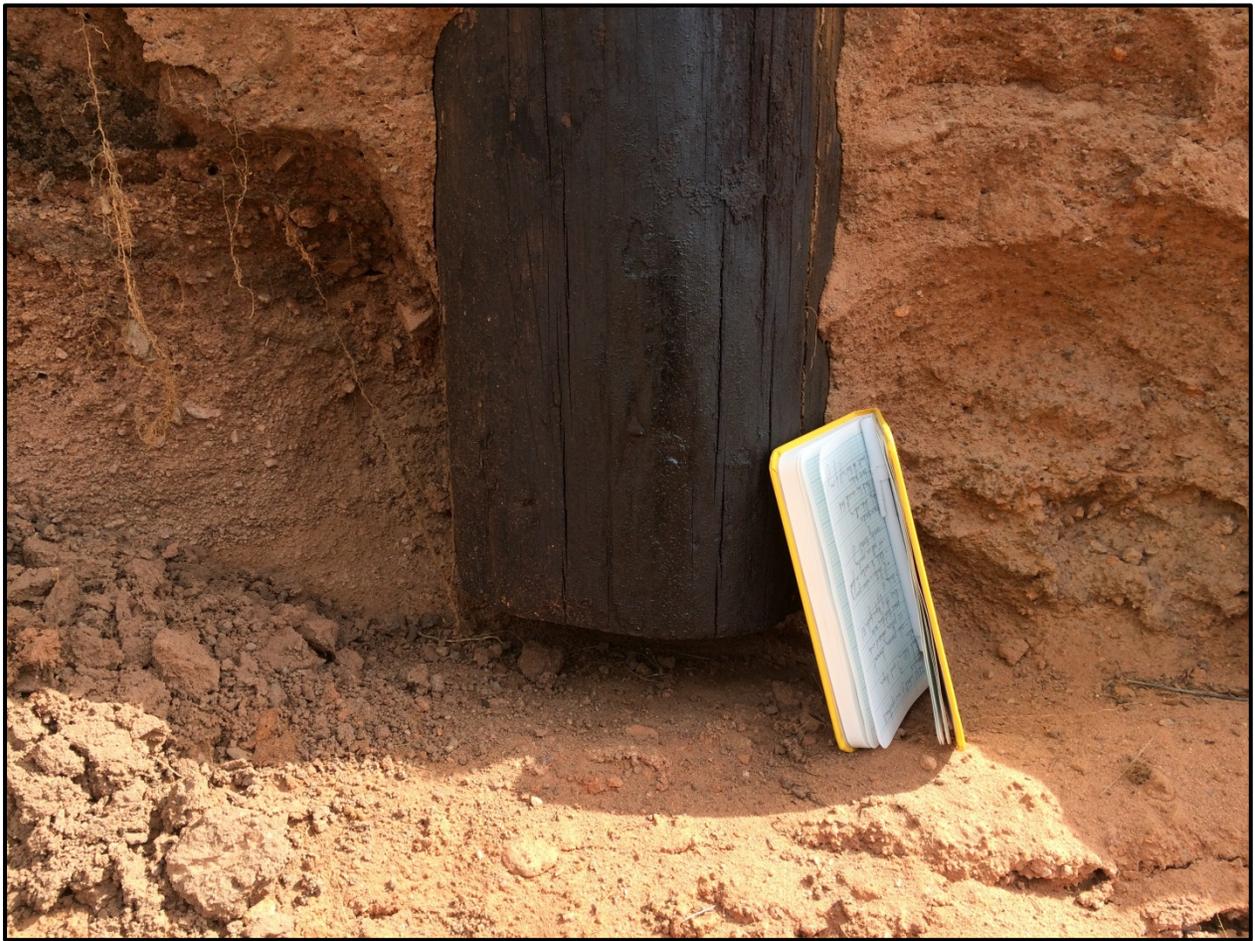
Figure 6 Erosion of a Utility Pole Foundation in the River-Left Bank

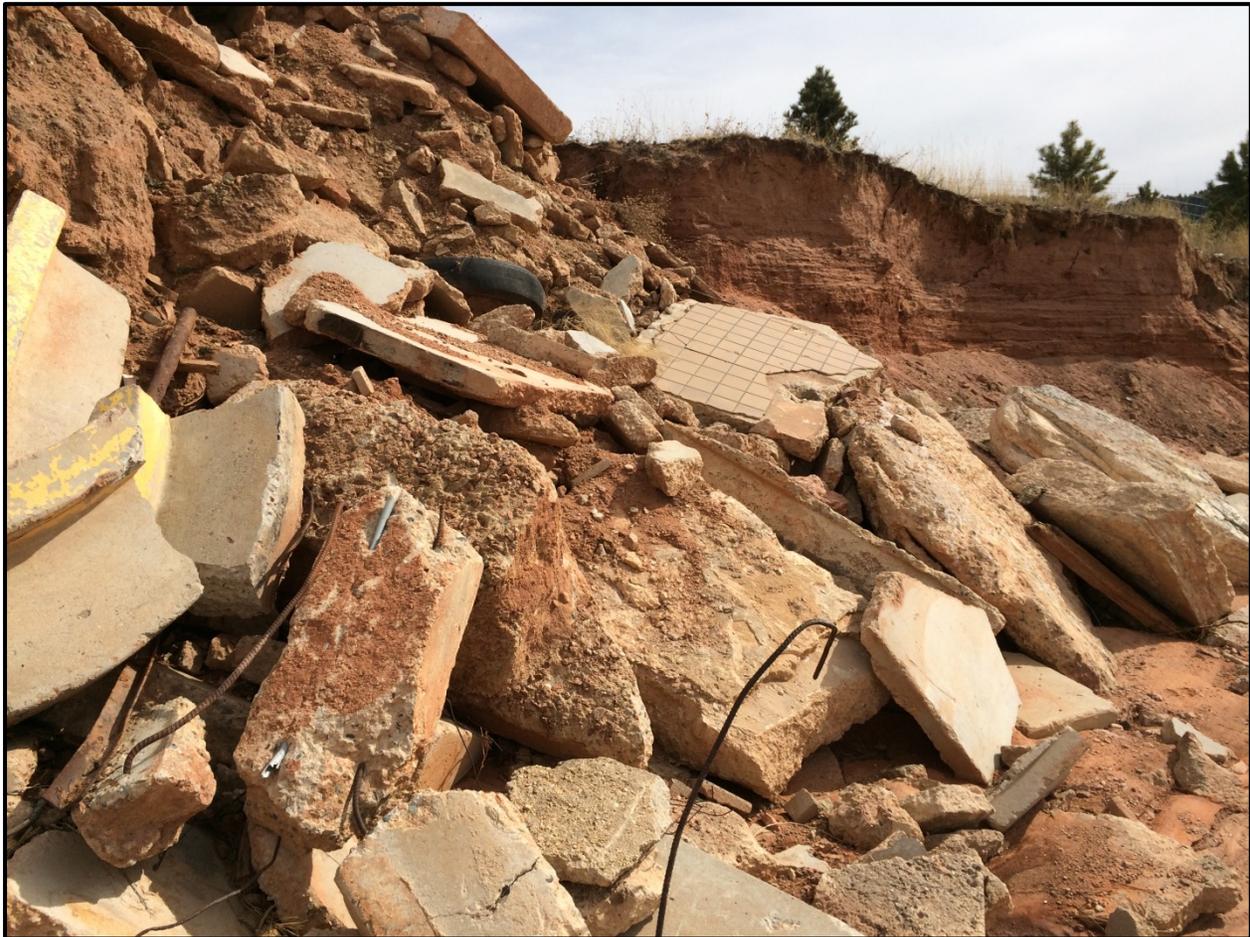
Figure 7 Construction Debris, River-Left, Across From the Concrete Plant

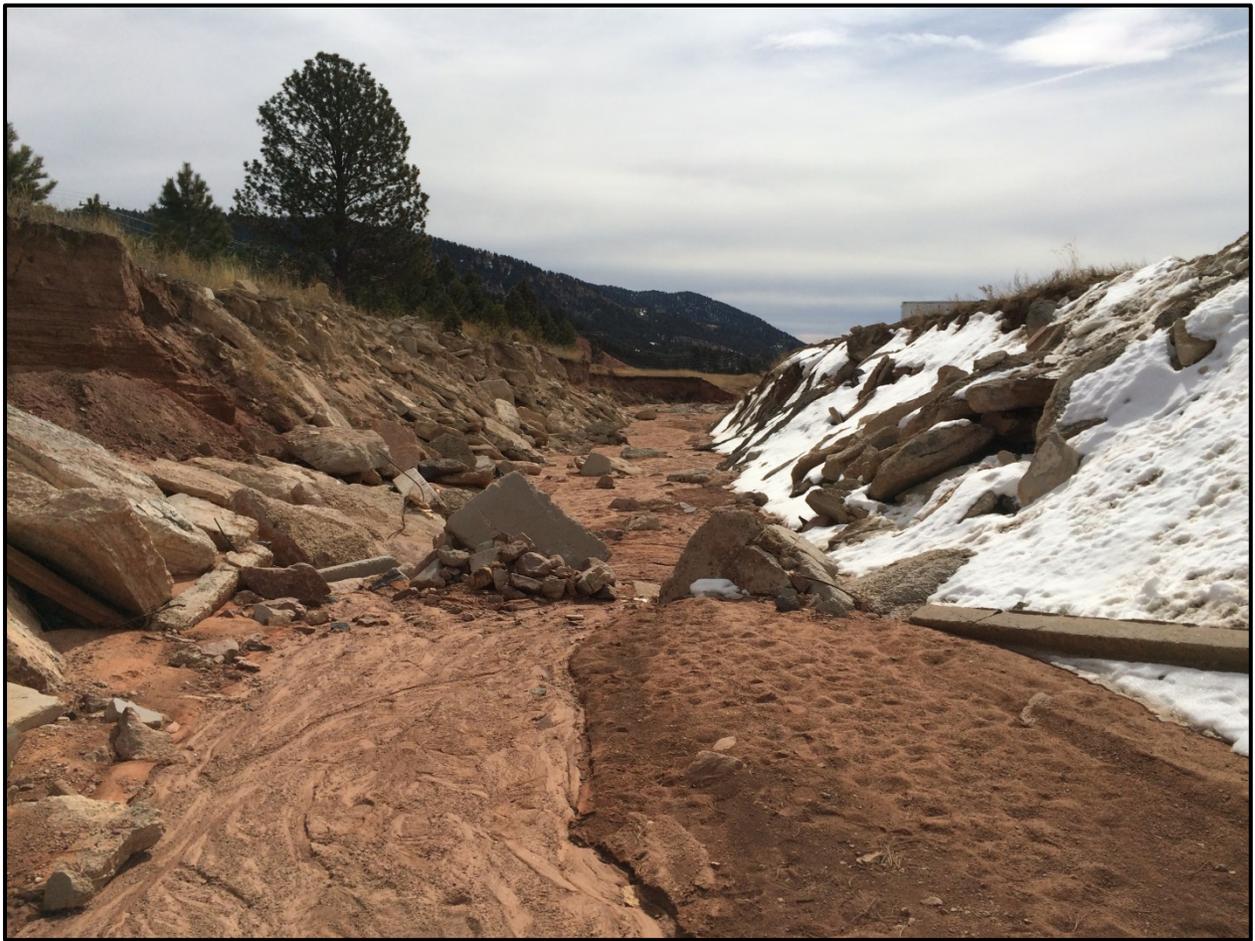
Figure 8 Bank Protection at the Concrete Plant; View Looking Downstream

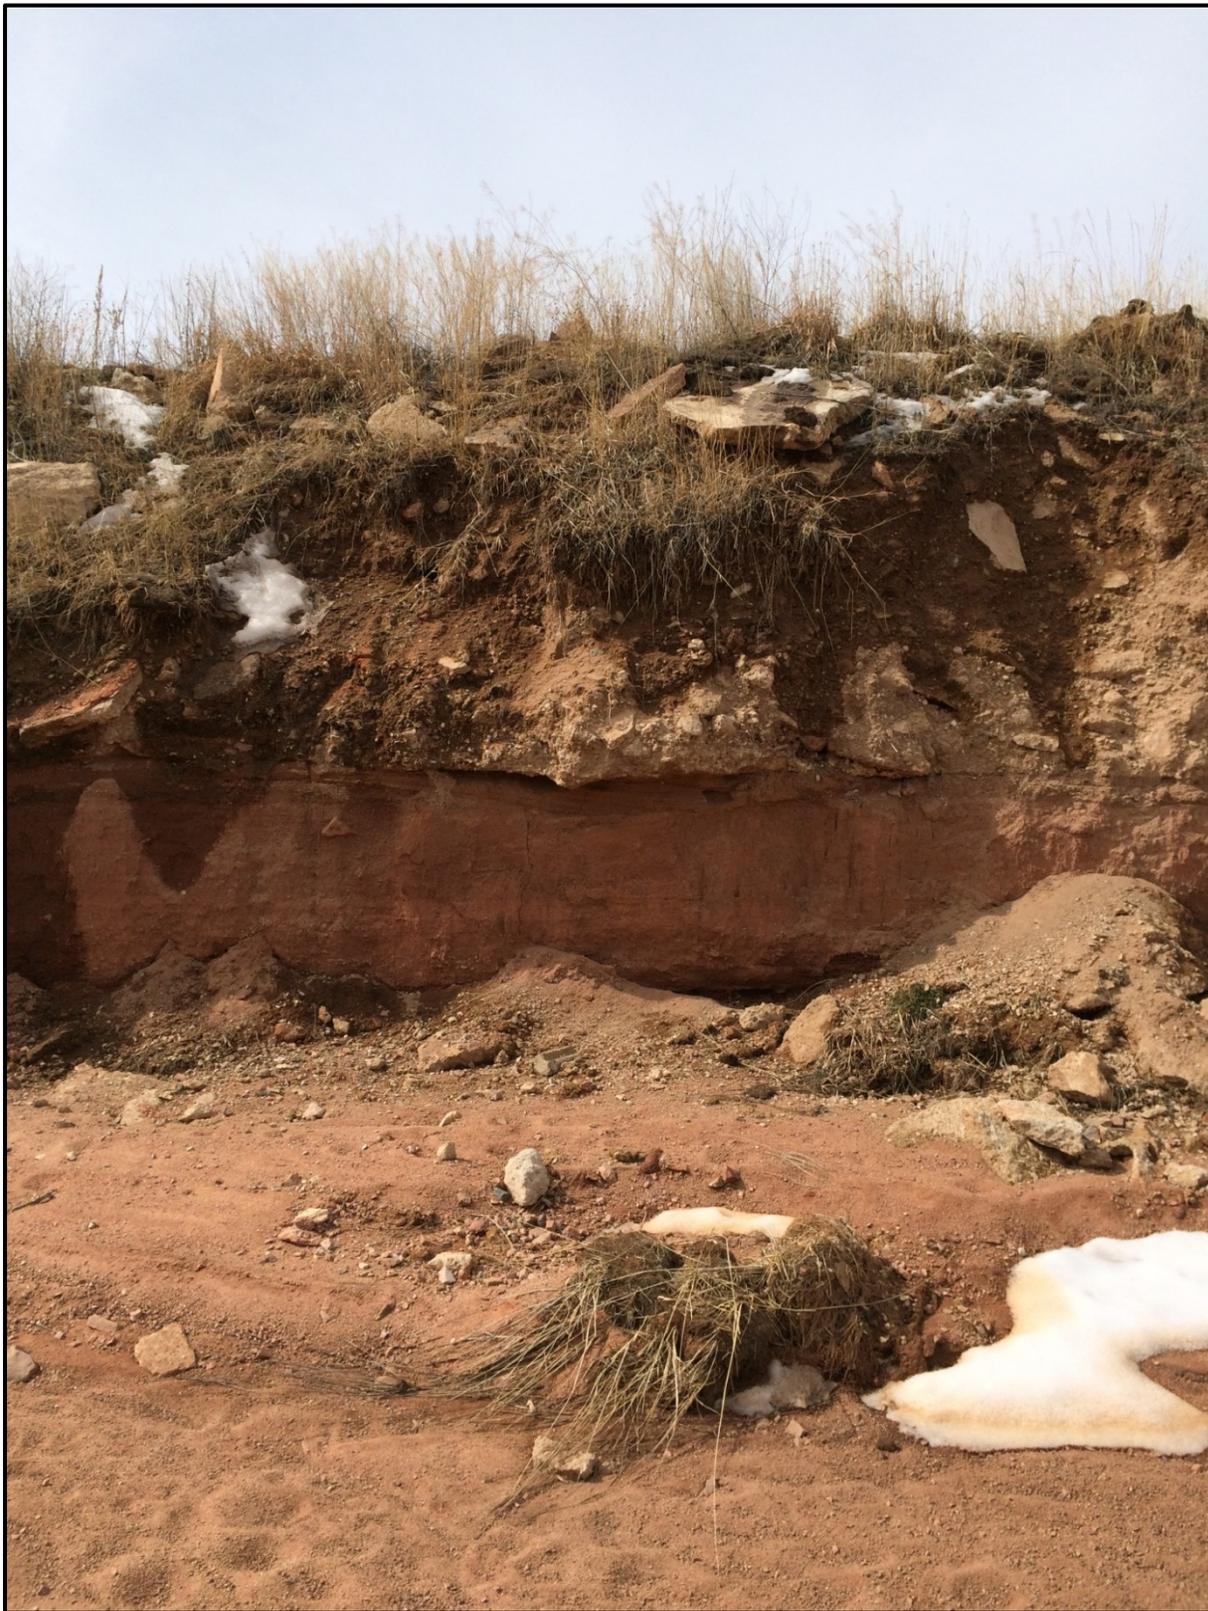
Figure 9 Fill Placed on Top of Former Floodplain; View is toward the River-Right Downstream of the Concrete Plant

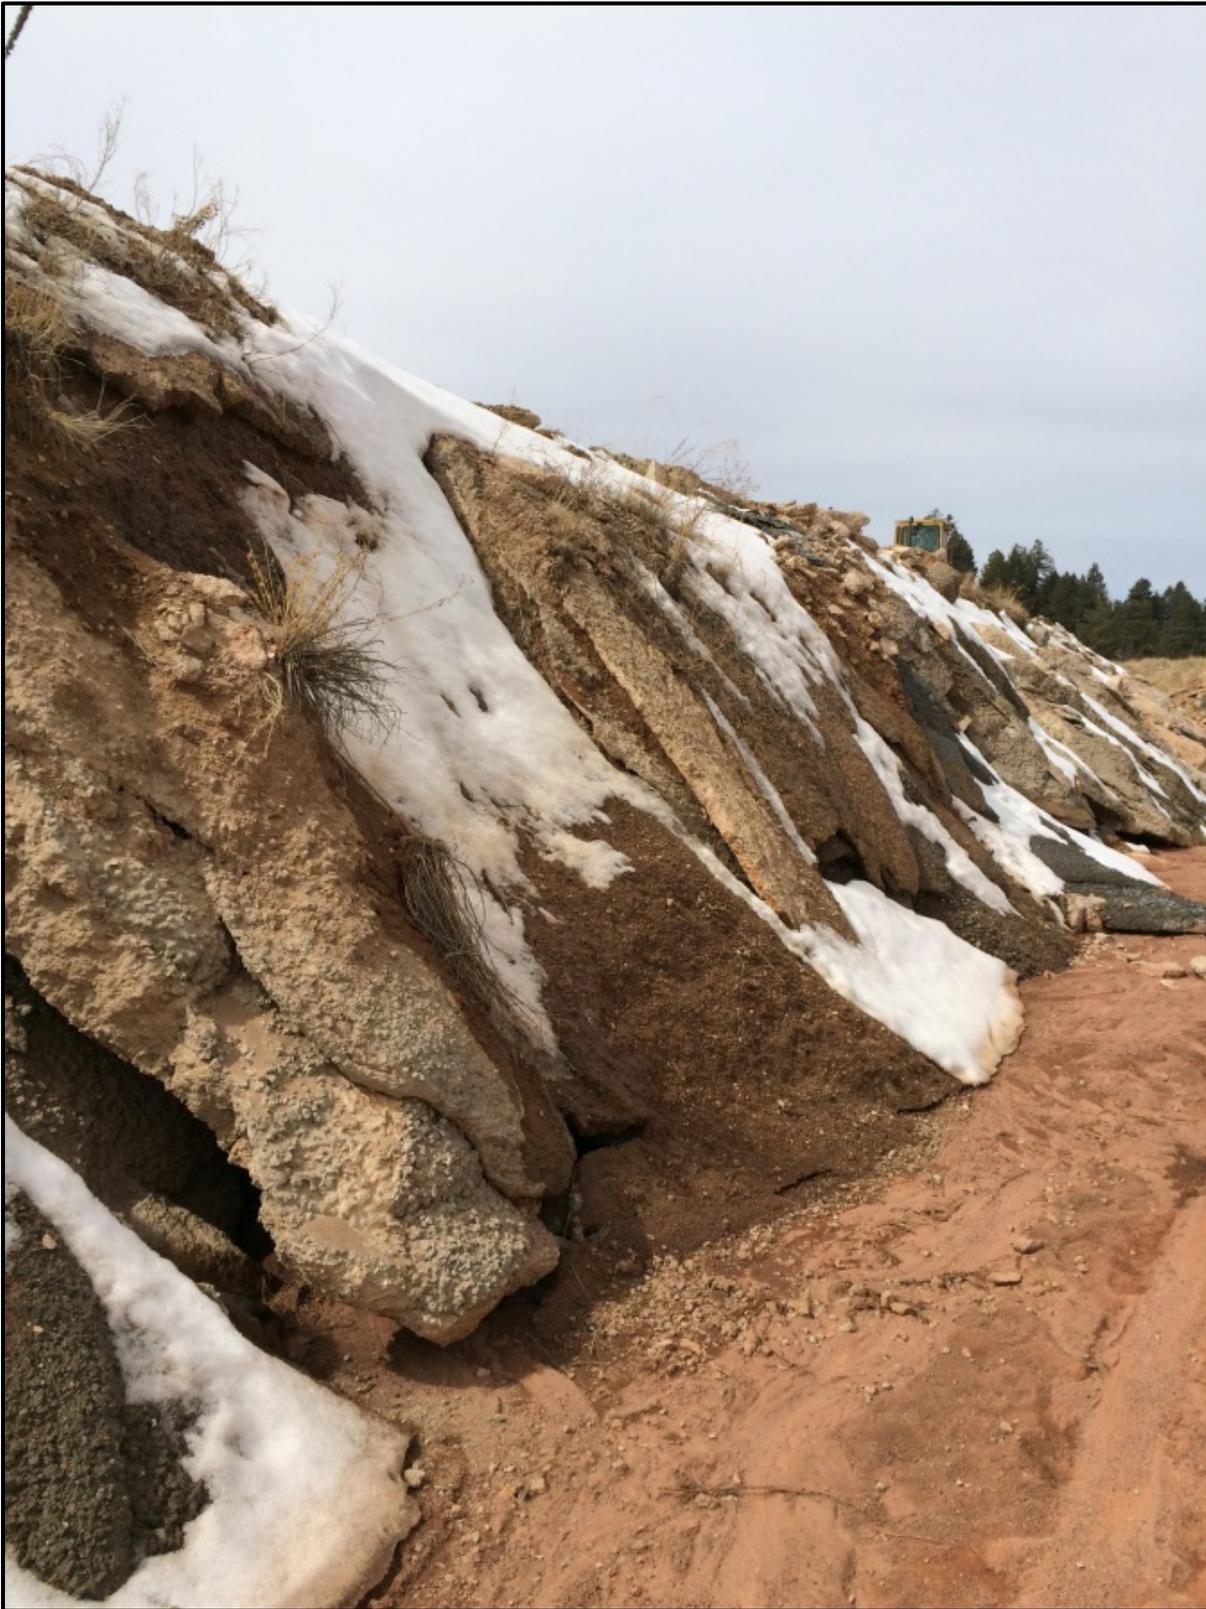
Figure 10 Poured Concrete on the River-Right Bank at the Concrete Plant; View Looking Upstream

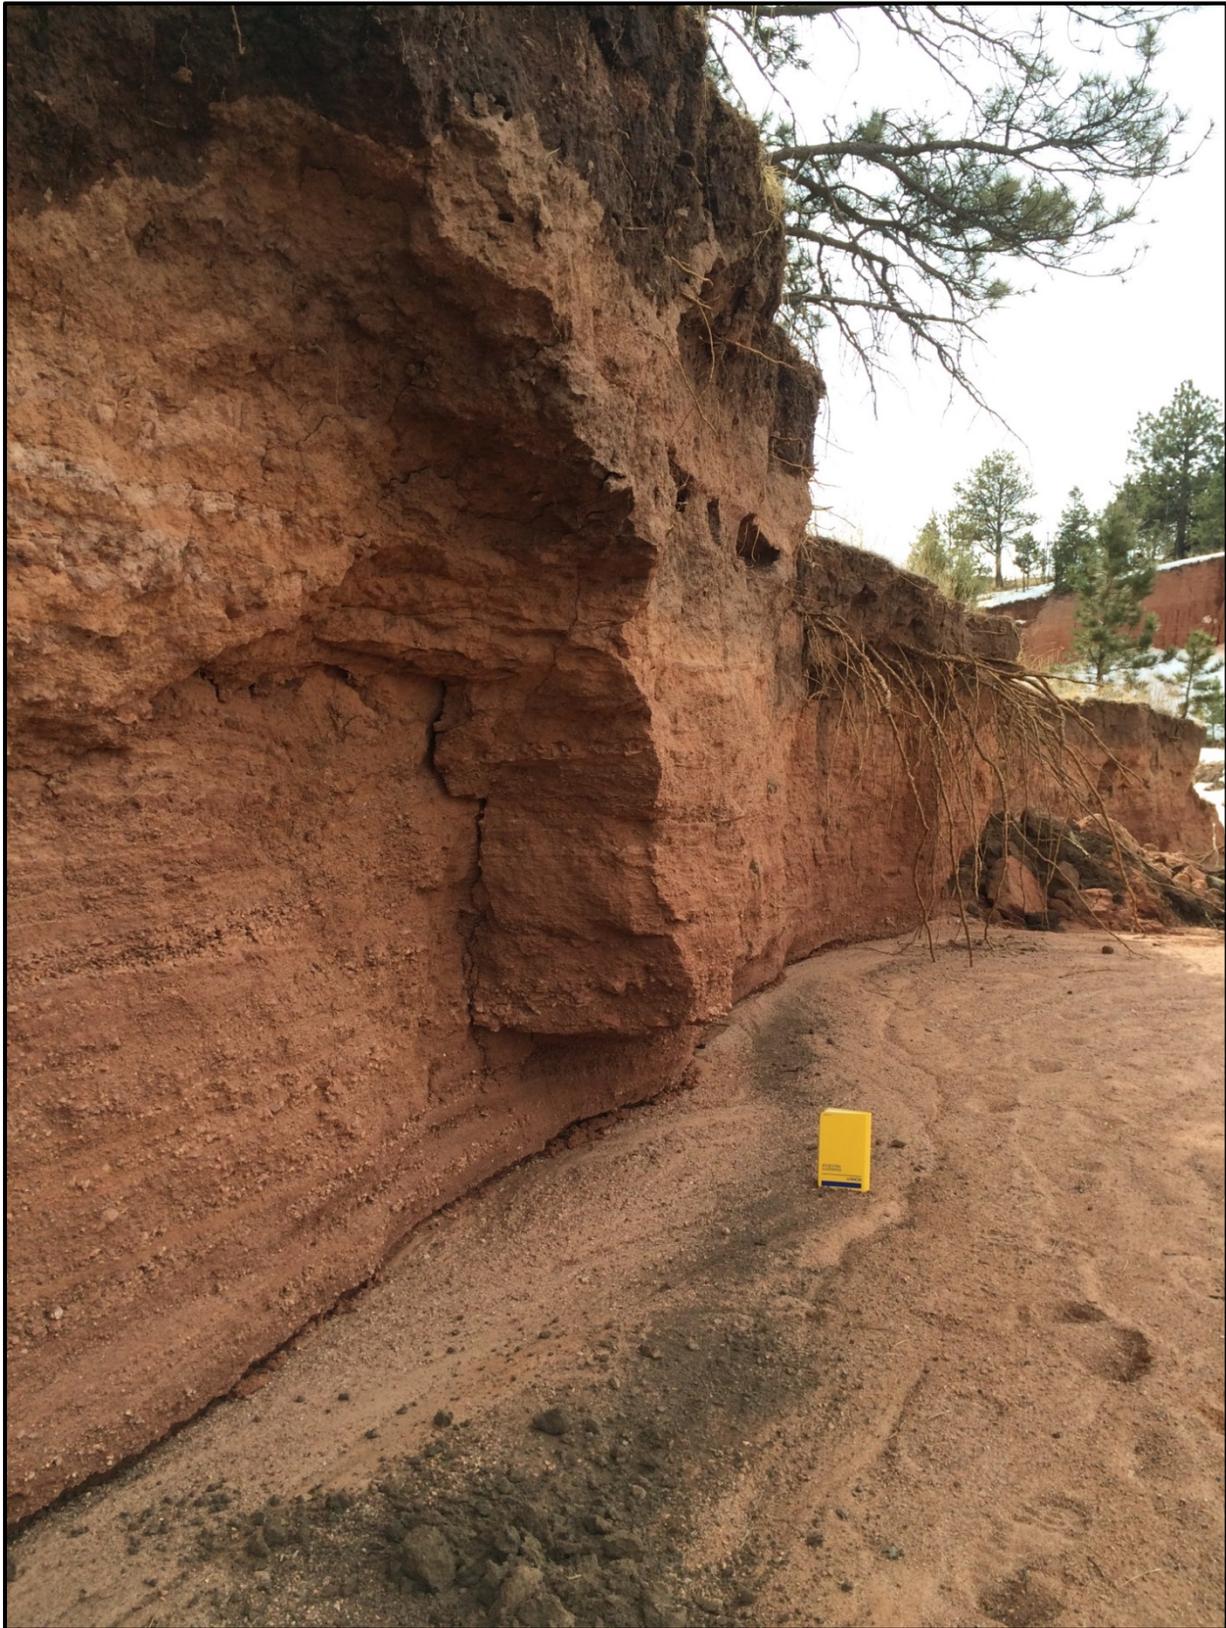
In the further downstream portions of the Concrete Plant Reach, the addition of fill material to the river-right bank ceases and a modern floodplain and channel bank have formed. However, this self-forming portion of the river is relatively short as the channel is constrained again shortly downstream, with construction debris stabilization material on the river-left and a natural sediment bluff on the river-right. The natural sediment bluff is being eroded by the channel, and has been stabilized at the toe by conventional riprap and construction debris (Figure 12). Within the downstream portion of the Concrete Plant Reach, the river contains such features as large sediment block failure of river-left bank, and an island separated from the higher banks by a secondary channel (Figure 11).

Figure 11 Sediment Block Erosion Pattern on River-Left Bank; View Looking Downstream

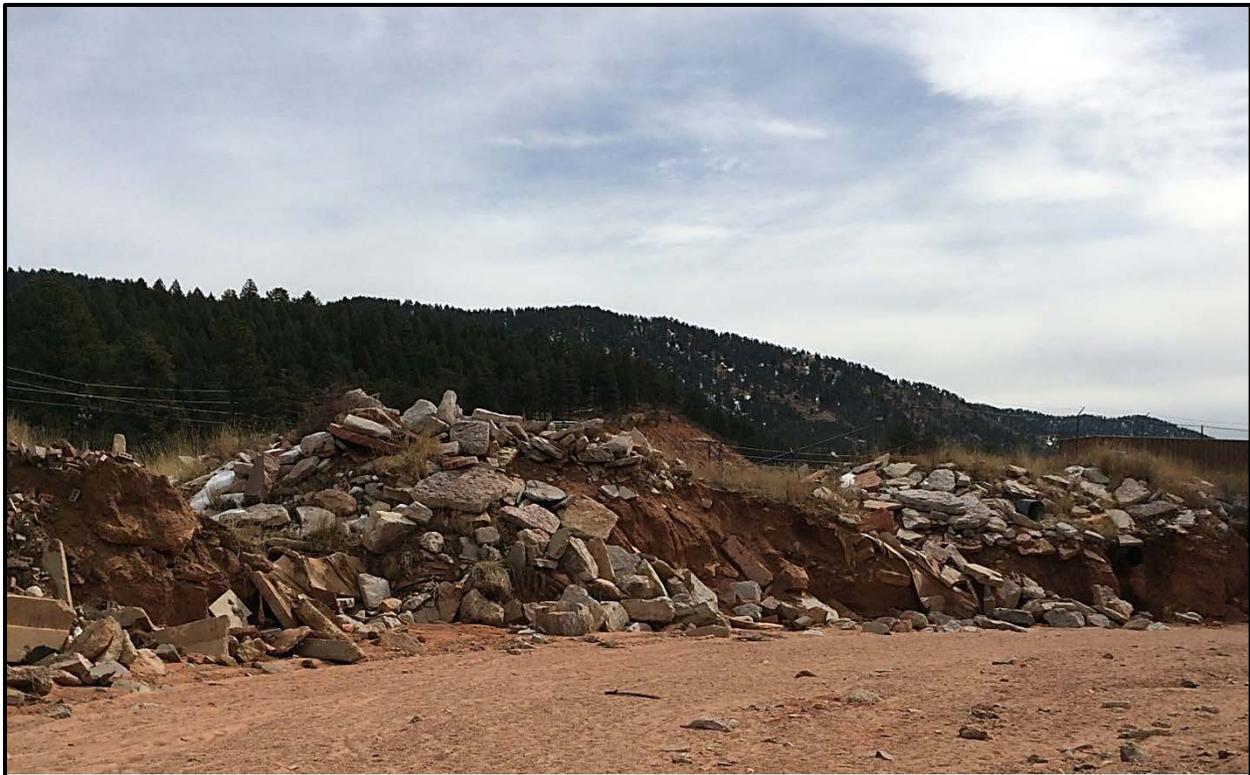
At the upstream end of the Saddle Club Reach, a culvert outlet and surface channel join the main channel from the river left. The discharge point of the culvert is not flush with the channel and discharges several feet above the elevation of the channel bed. The surface channel is also associated with significant erosion. This has resulted in erosion and the remedial efforts, which consist of the addition of a large quantity of construction debris and large boulders within the surface channel and the culvert outlet (Figure 13).

Figure 13 Culvert Joins from River-Left; View is toward the River-Left

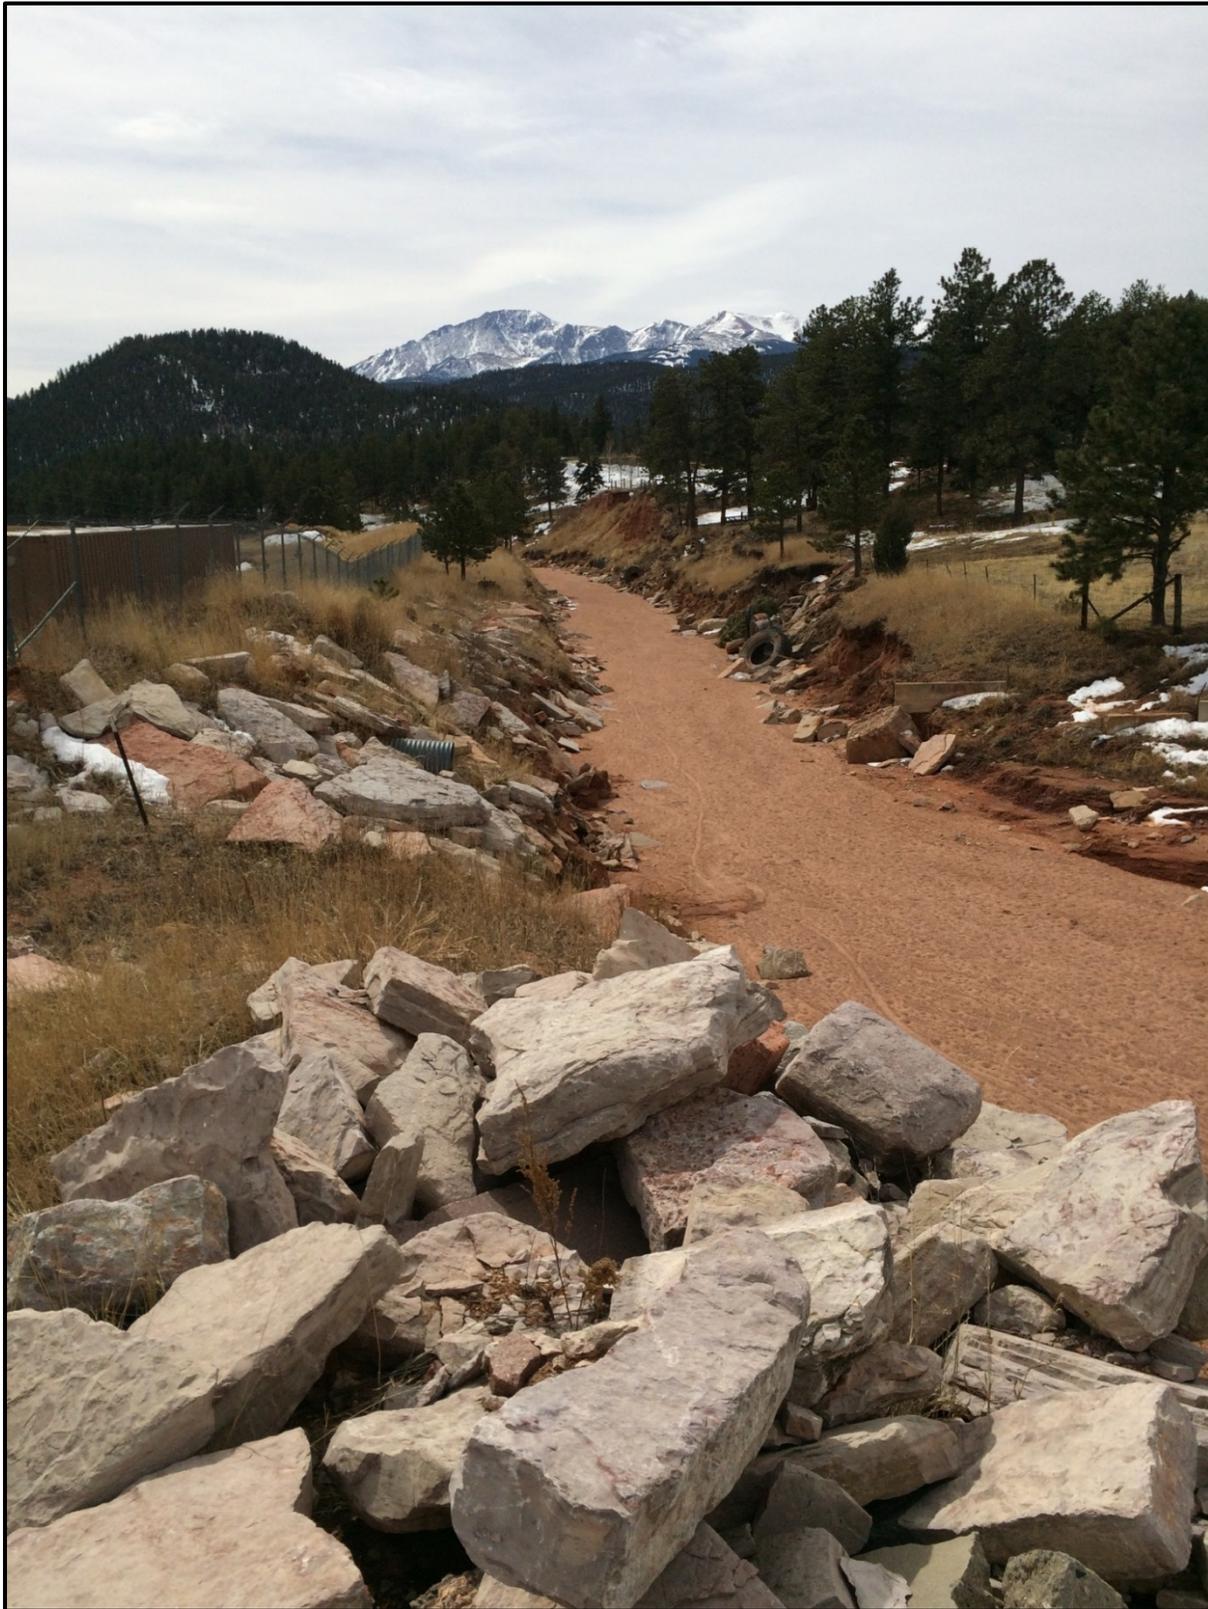
Starting in the downstream portion of the Concrete Plant Reach and continuing through the Saddle Club Reach and into the upper portion of the Walmart Reach, the river-left bank has had several feet of fill material added to the floodplain. Golder believed that a large portion of this fill material is associated with the construction of the reservoir on the river-left bank. According to the aerial imagery collected during this investigation, the reservoir was constructed sometime between 1954 and 1971 (see Figure 27 and Figure 28) and drained sometime between 1988 and 1999 (see Figure 31 and Figure 32). The reservoir embankments are still present on the floodplain and the long side of the trapezoidal shaped reservoir runs parallel to the channel for most of the downstream portion of the Saddle Club Reach.

Figure 14 Saddle Club Reach is Lined on Both Sides by Large Quantities of Revetment Material; View Looking Downstream

For most of Study Reach from Aspen Garden Bridge to the top of the Walmart Reach, the banks and especially the toe of the banks have been lined with un-designed revetment material. This intention in placing this material was undoubtedly to protect the banks of the channel from further erosion. The material consists of construction debris, waste rock, left over concrete, old tires, car bodies, and an assortment of other items. While well intentioned, the placement of these materials in a haphazard fashion has resulted in insufficient erosion protection and a public eyesore. Golder recommends the complete removal and redesign of all of the bank protection and erosion revetment present between Aspen Garden Bridge and the downstream end of the Saddle Club Reach.

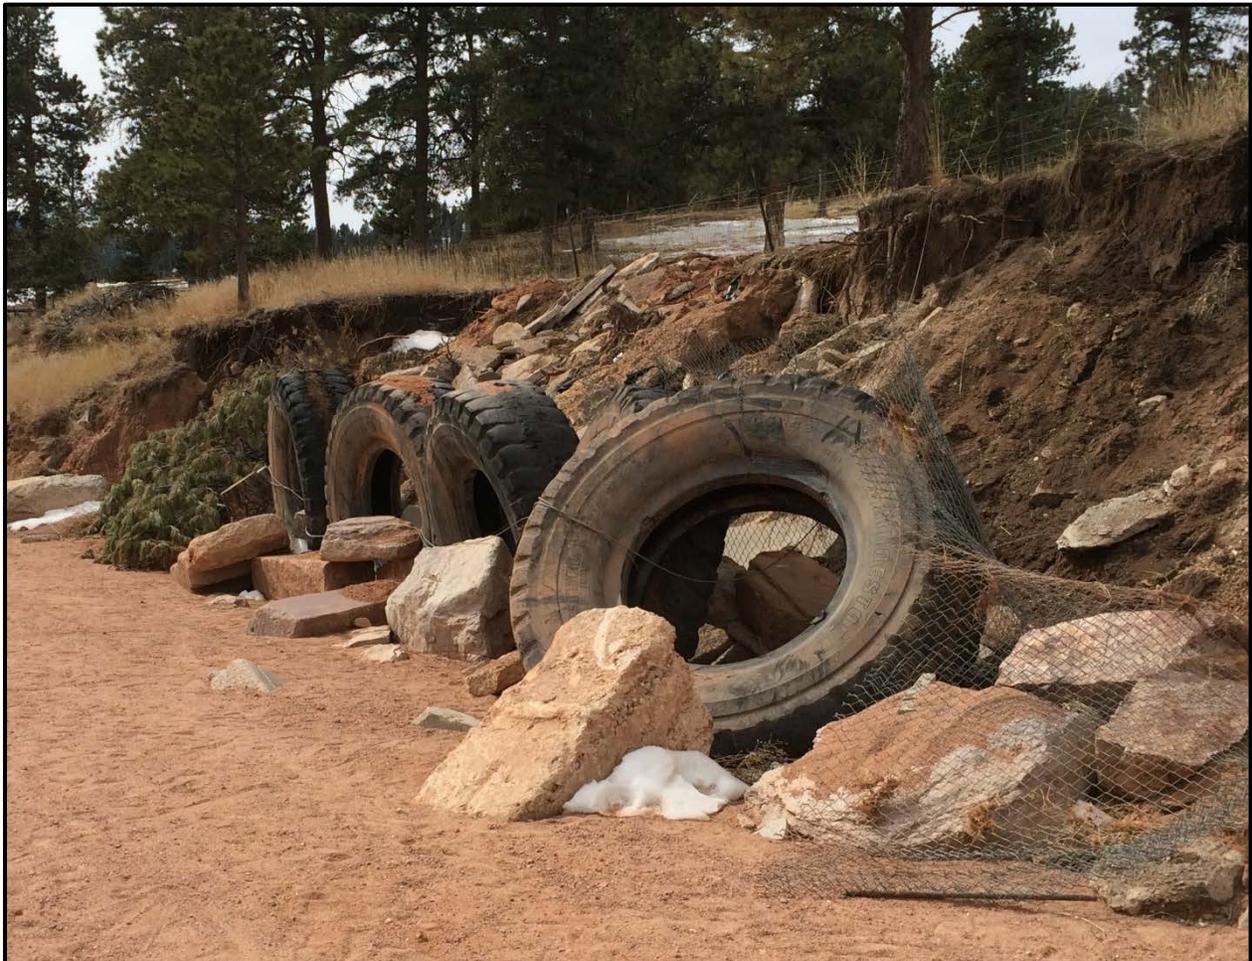
Through most of the Saddle Club Reach and into the upper part of the Walmart Reach, the river-right bank is being eroded. The bank consists of a bluff made of in situ valley sediments. Along most of the Saddle Club Reach the toe of the bluff, where it meets the river banks, is protected by riprap, construction debris, and many very large tires, and in one instance, an old rusted car body (Figure 16). These tires likely came from nearby mining operations and have been chained together for the purpose of protecting the bank from erosion (Figure 15).

Figure 15 One of Several Sets of Large Tires Placed on the River-Right Bank with the Saddle Club Reach

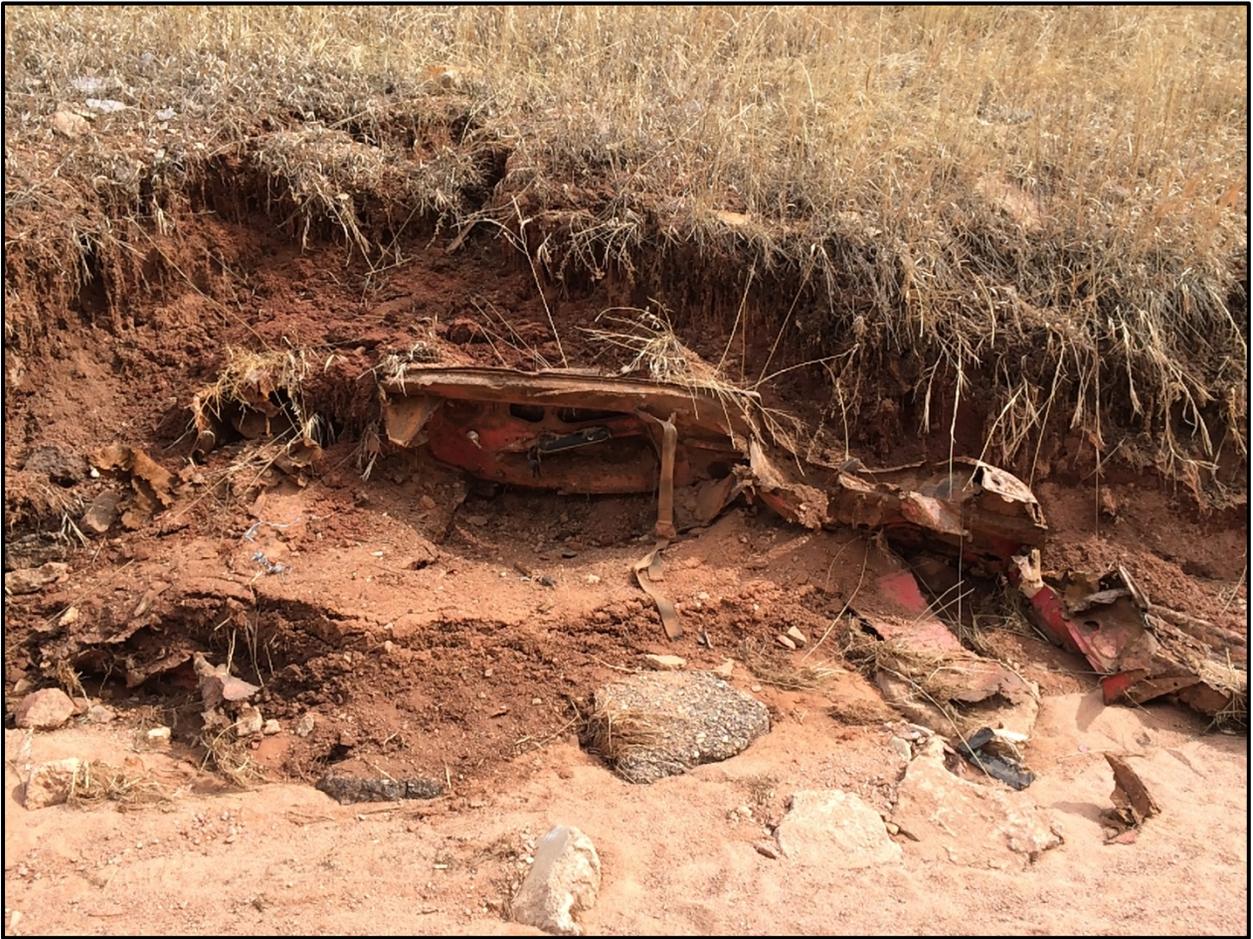
Figure 16 Car Body Used as Bank Protection; View is toward the River-Left

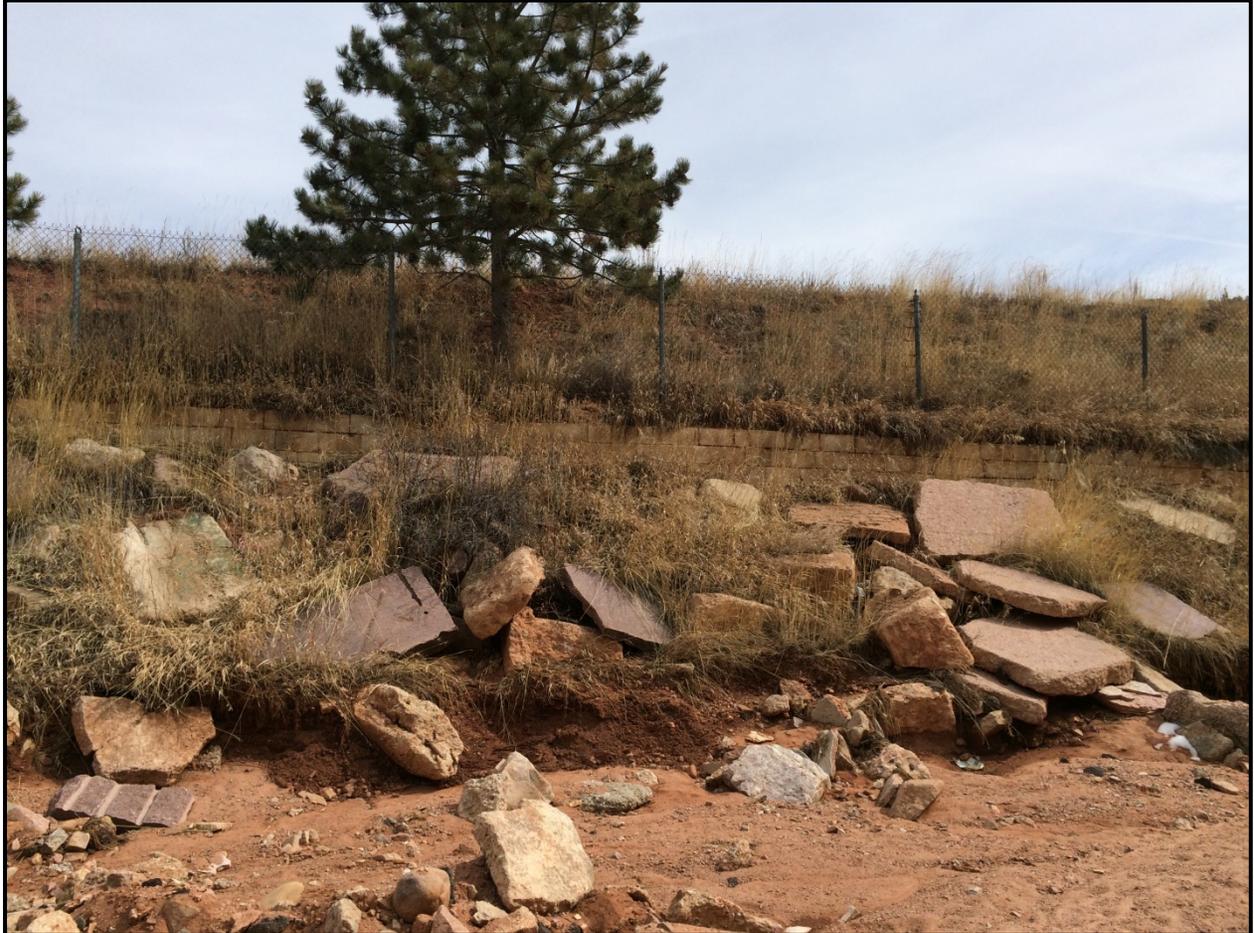
Figure 17 Retaining Wall at Downstream End of Saddle Club Reach; View is toward the River-Left

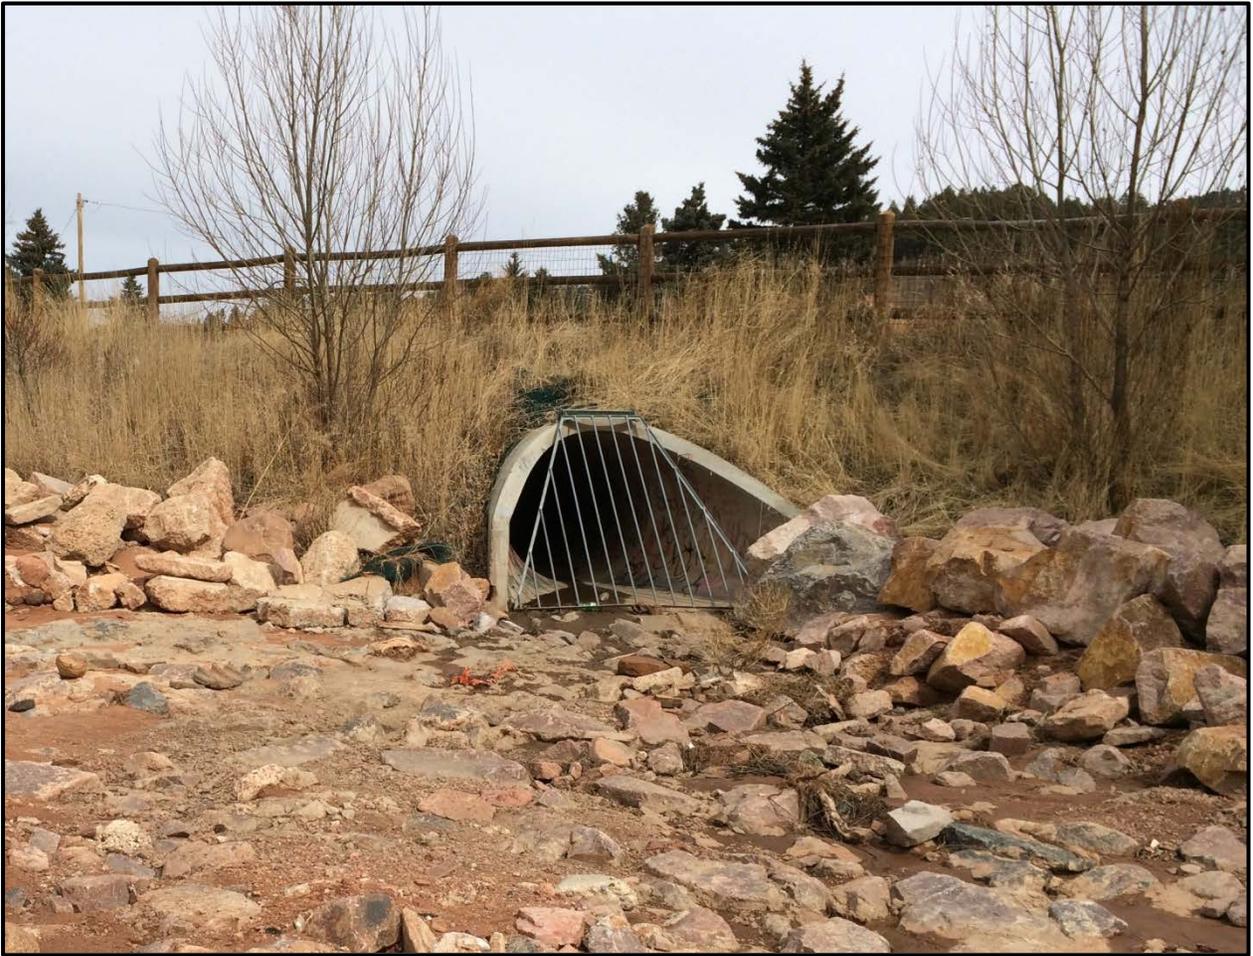
Figure 19 Culvert Outlet at Upstream End of Walmart Reach on River-Left

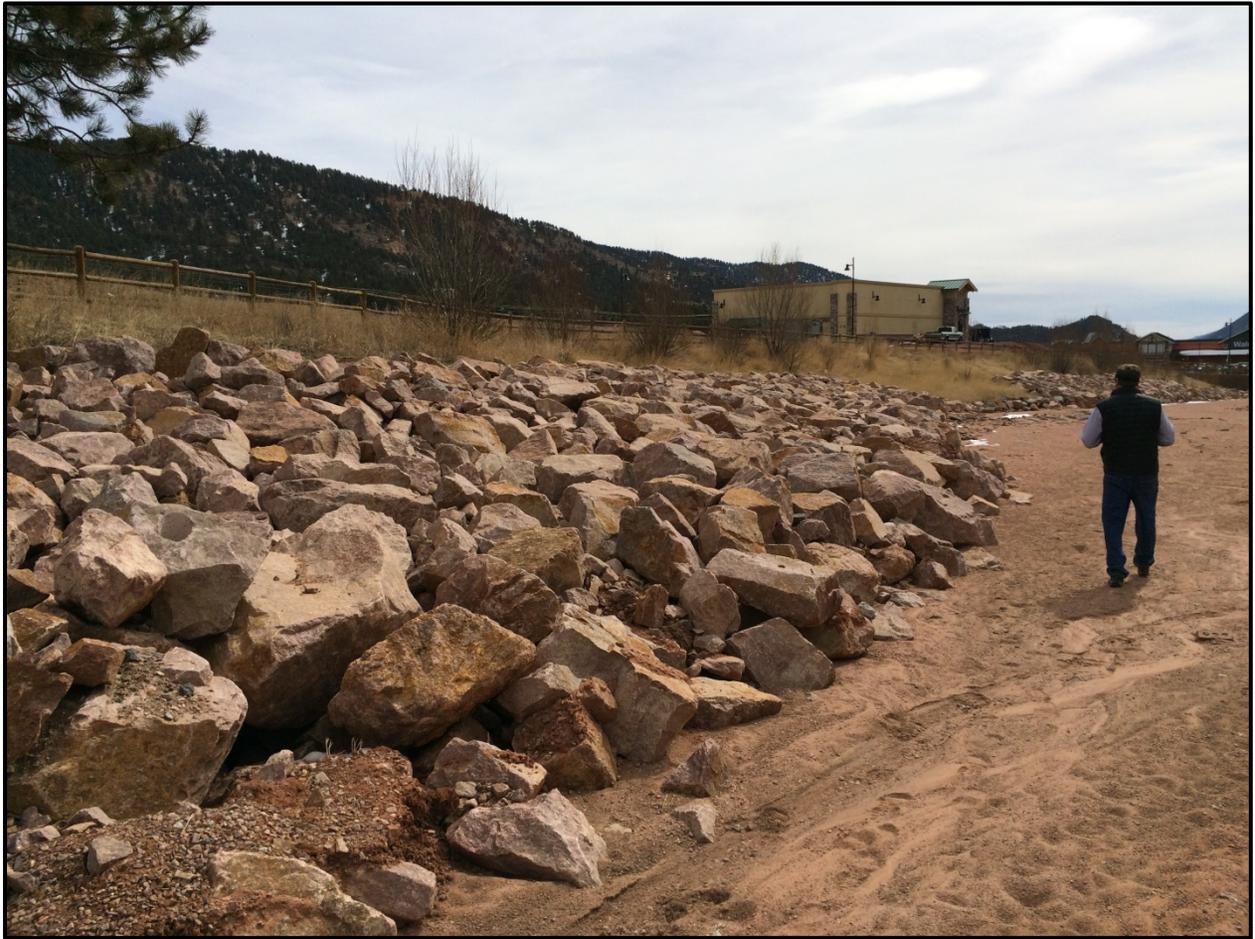
Figure 20 Large Riprap on River-Left Bank at Upstream End of Walmart Reach
