GEOMORPHIC ASSESSMENT

**Fountain Creek in Woodland Park between
Aspen Garden Road and Crystola Road**

Submitted By: Golder Associates Inc.
44 Union Boulevard, Suite 300
Lakewood, Colorado 80228

June 29, 2015

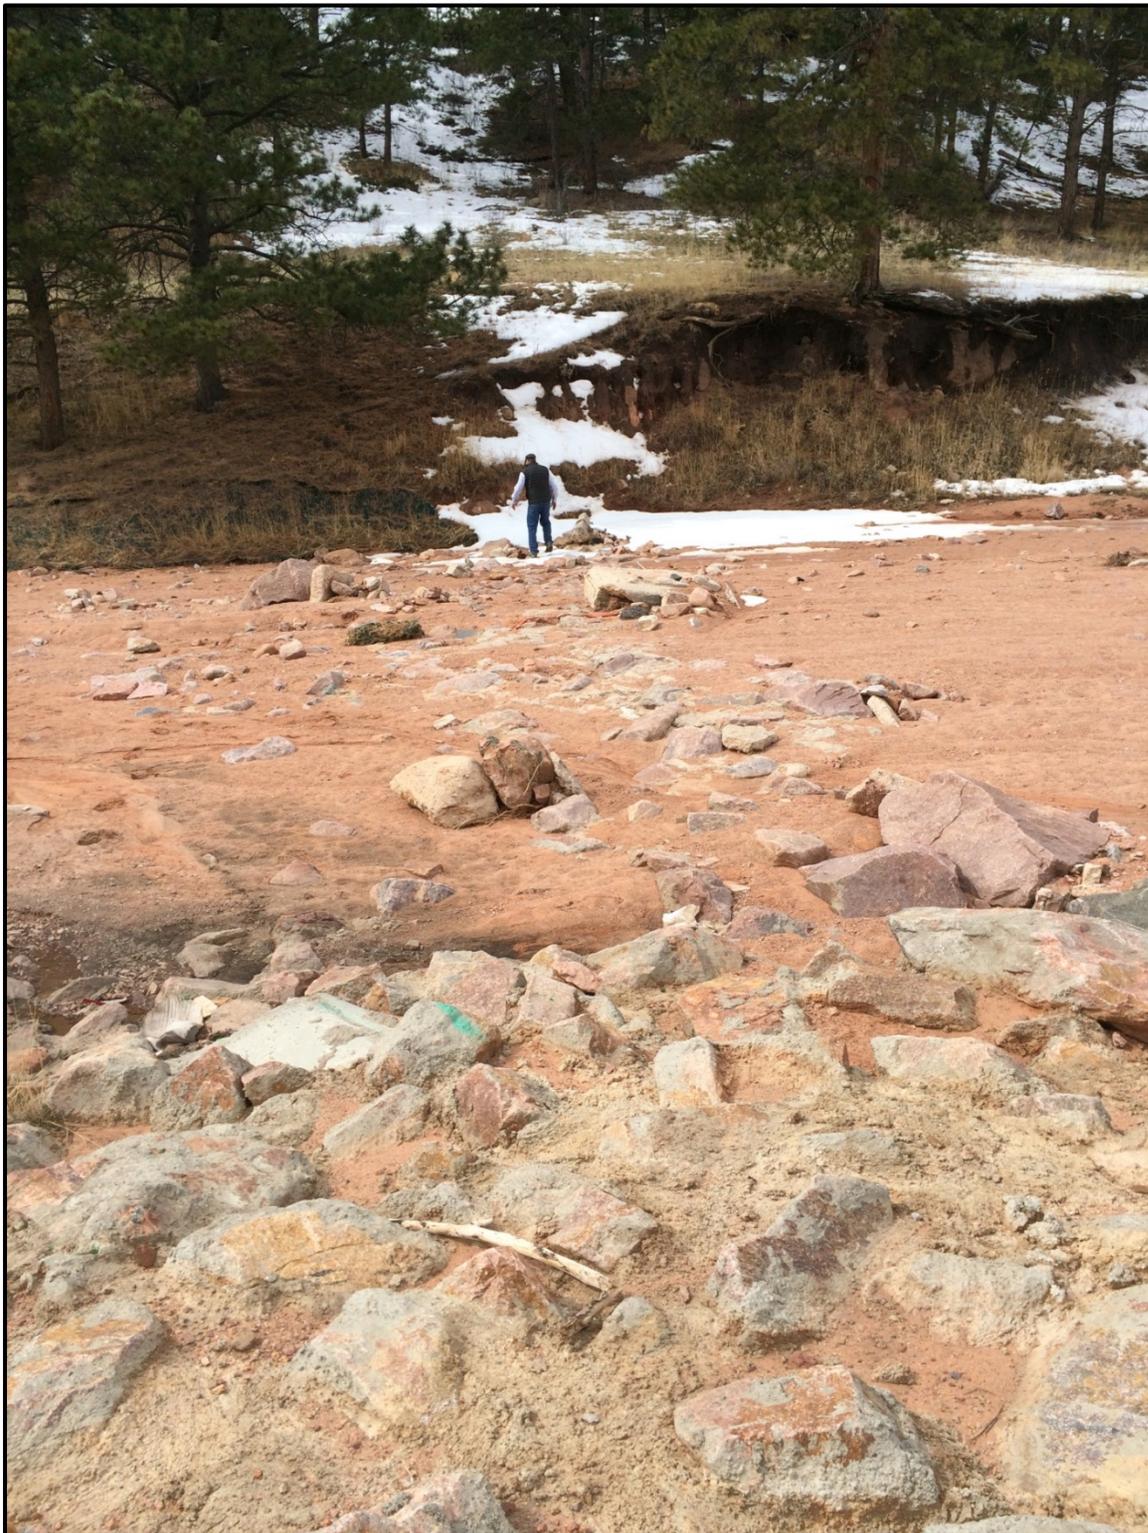
Note: The erosion is on the far bank.

Figure 21 The Drop Structure near the Upstream End of the Walmart Reach; View is toward the River-Right

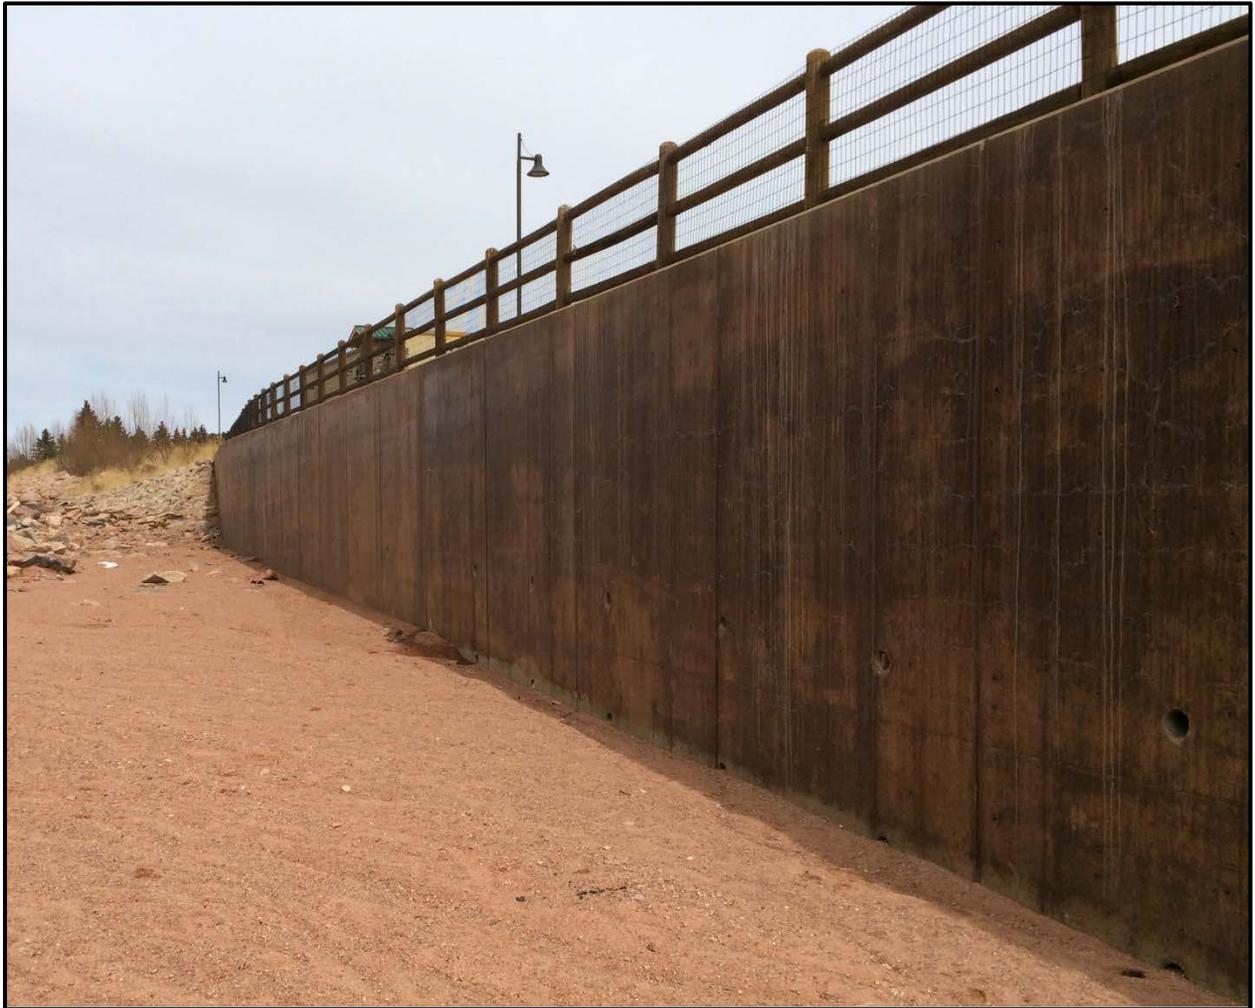
Figure 22 River-Left Retaining Wall in Walmart Reach; View Looking Upstream
