GEOMORPHIC ASSESSMENT

**Fountain Creek in Woodland Park between
Aspen Garden Road and Crystola Road**

Submitted By: Golder Associates Inc.
44 Union Boulevard, Suite 300
Lakewood, Colorado 80228

June 29, 2015

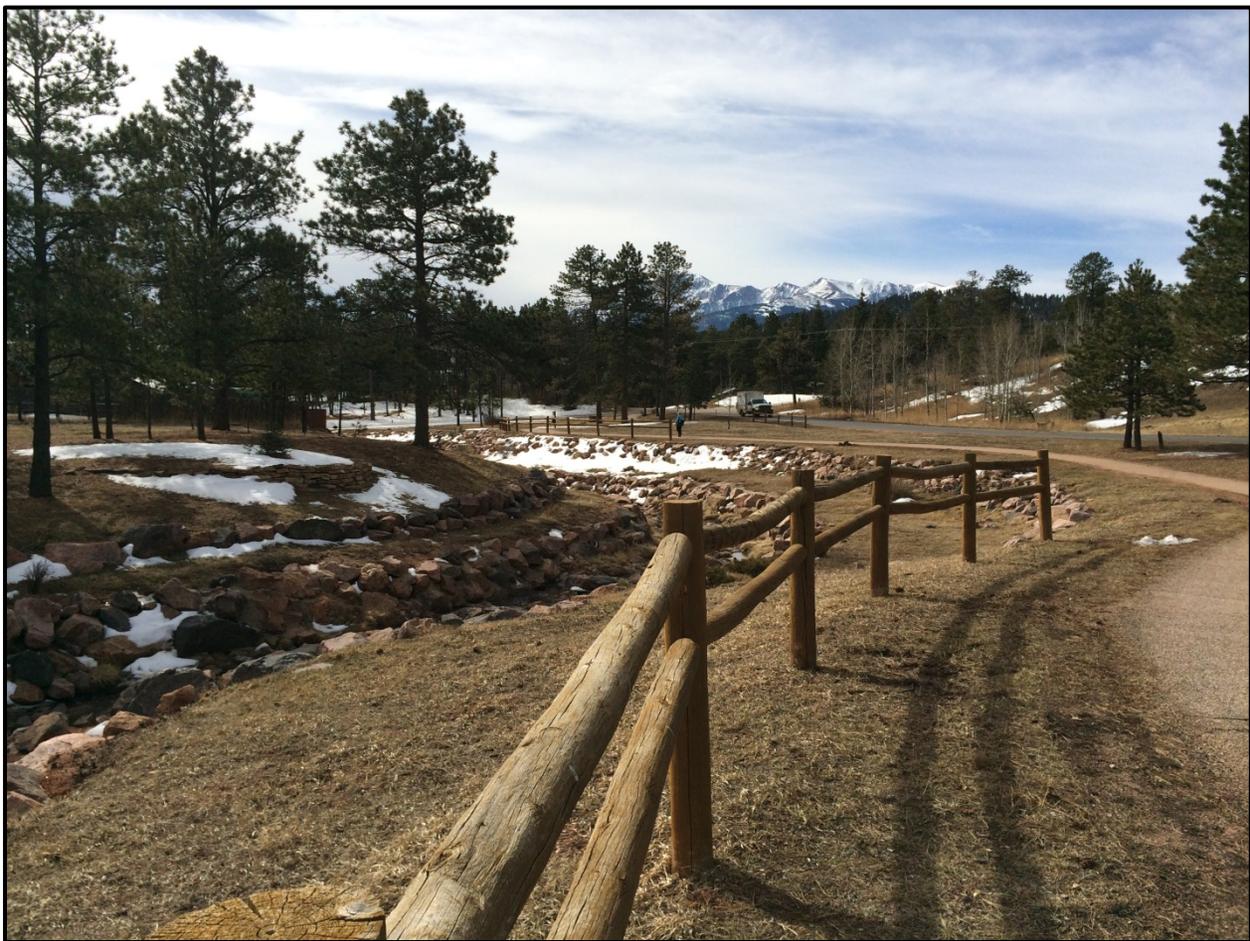
Figure 2 Typical Channel Upstream of the Study Reach; View Looking Downstream from Cavalier Park

Large portions of the Fountain Creek Watershed upstream from the Site have been stabilized via culverts, drop structures, and hard stabilization techniques. The frequent use of culverts and grouted riprap have substantially stabilized the channel bed and banks upstream from the Study Reach and minimized the potential for bank erosion and lateral channel migration in large portions of the upstream basin (Figure 2). Additionally, the construction of two retention basins upstream of the site will likely attenuate the passage of a flood wave, consequently reducing peak discharges. However, in contrast to the largely protected channels of most of the drainage basin, the reach immediately upstream of the Study Reach has recently experienced significant erosion and has undergone substantial morphology change (Figure 3).

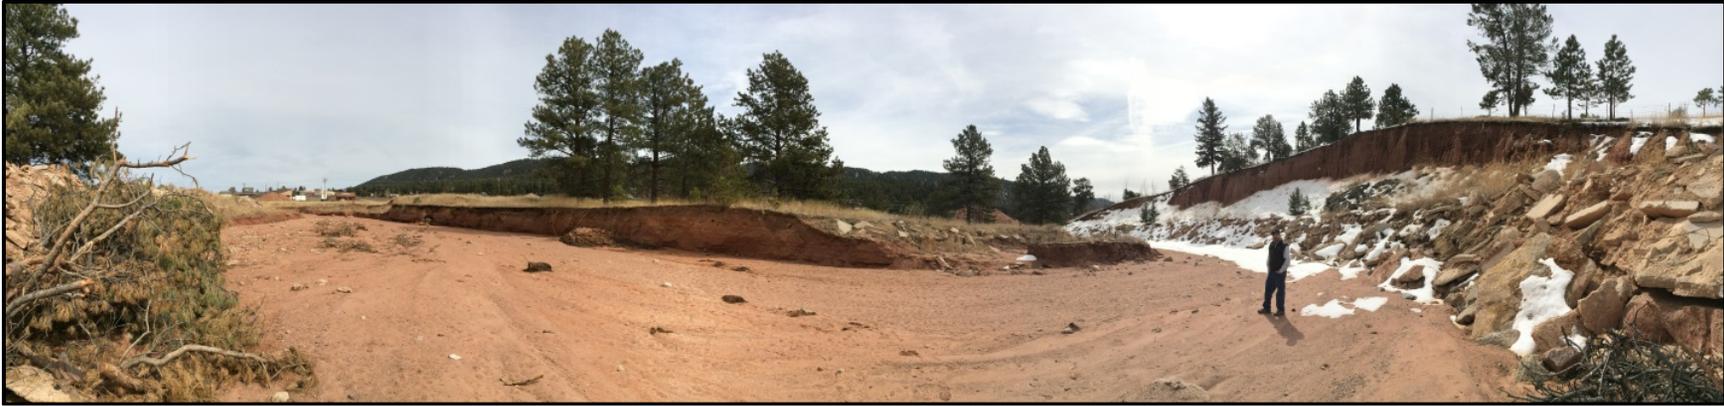
Figure 12 Downstream Portion of Concrete Plant Reach; Saddle Club Reach

Note: Modern floodplain formation at the upstream, left hand side of the image, the island and back-bar channel in the center, and the riprap protection bluff on the right side of the image. Flow is from left to right.

- No channel armoring, floodplain infilling, nor channel encroachment.
- Channel is eroding the in situ material in some places, notable at the downstream end of the Concrete Plant Reach. On the right hand, side of Figure 12 the high, eroded bank present in 1953 can be seen in its present day form.

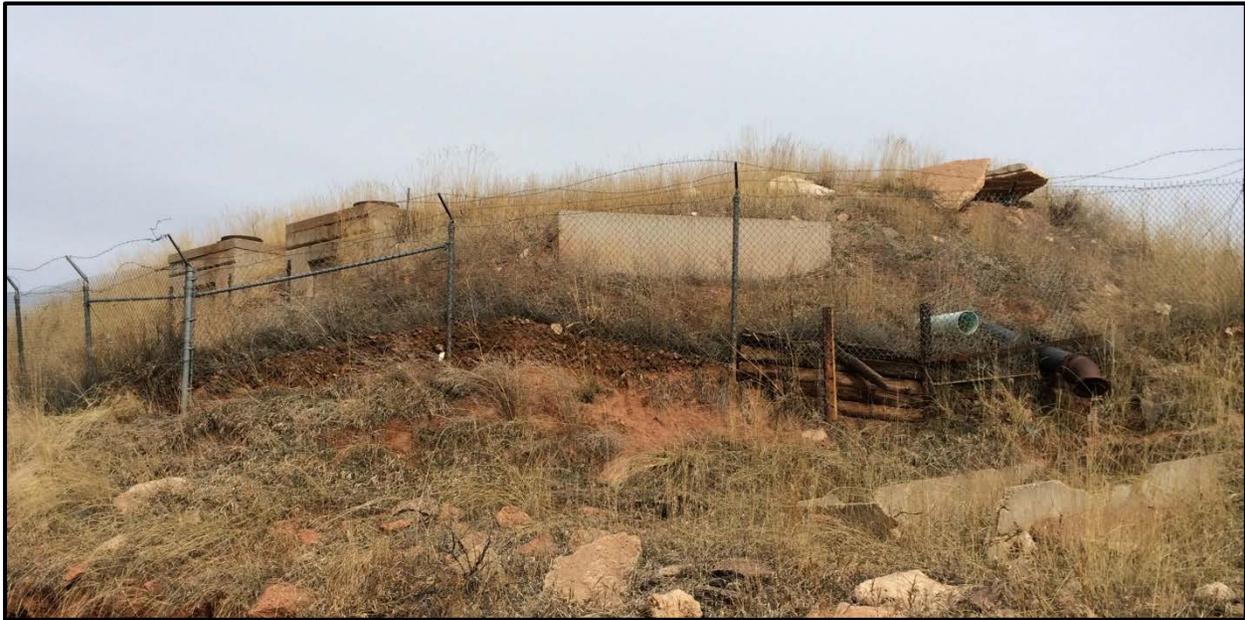
Figure 18 Reservoir Downstream Outlet Structures

The downstream end of the Saddle Club Reach is defined by the downstream end of the adjacent former Saddle Club. At the downstream end of the former reservoir, there are several structures associated with old outlets works and a retaining wall (Figure 17 and Figure 18).

In the modern configuration, three unnamed tributaries join the main stem of Fountain Creek from the river-left within the Study Reach. The first joins at the upstream end of the Saddle Club Reach at a heavily protected culvert outfall (see Figure 13). The second joins the river via the outlet works of the former reservoir (see Figure 18) and the third joins immediately downstream of the second via a grouted culvert (see Figure 19).

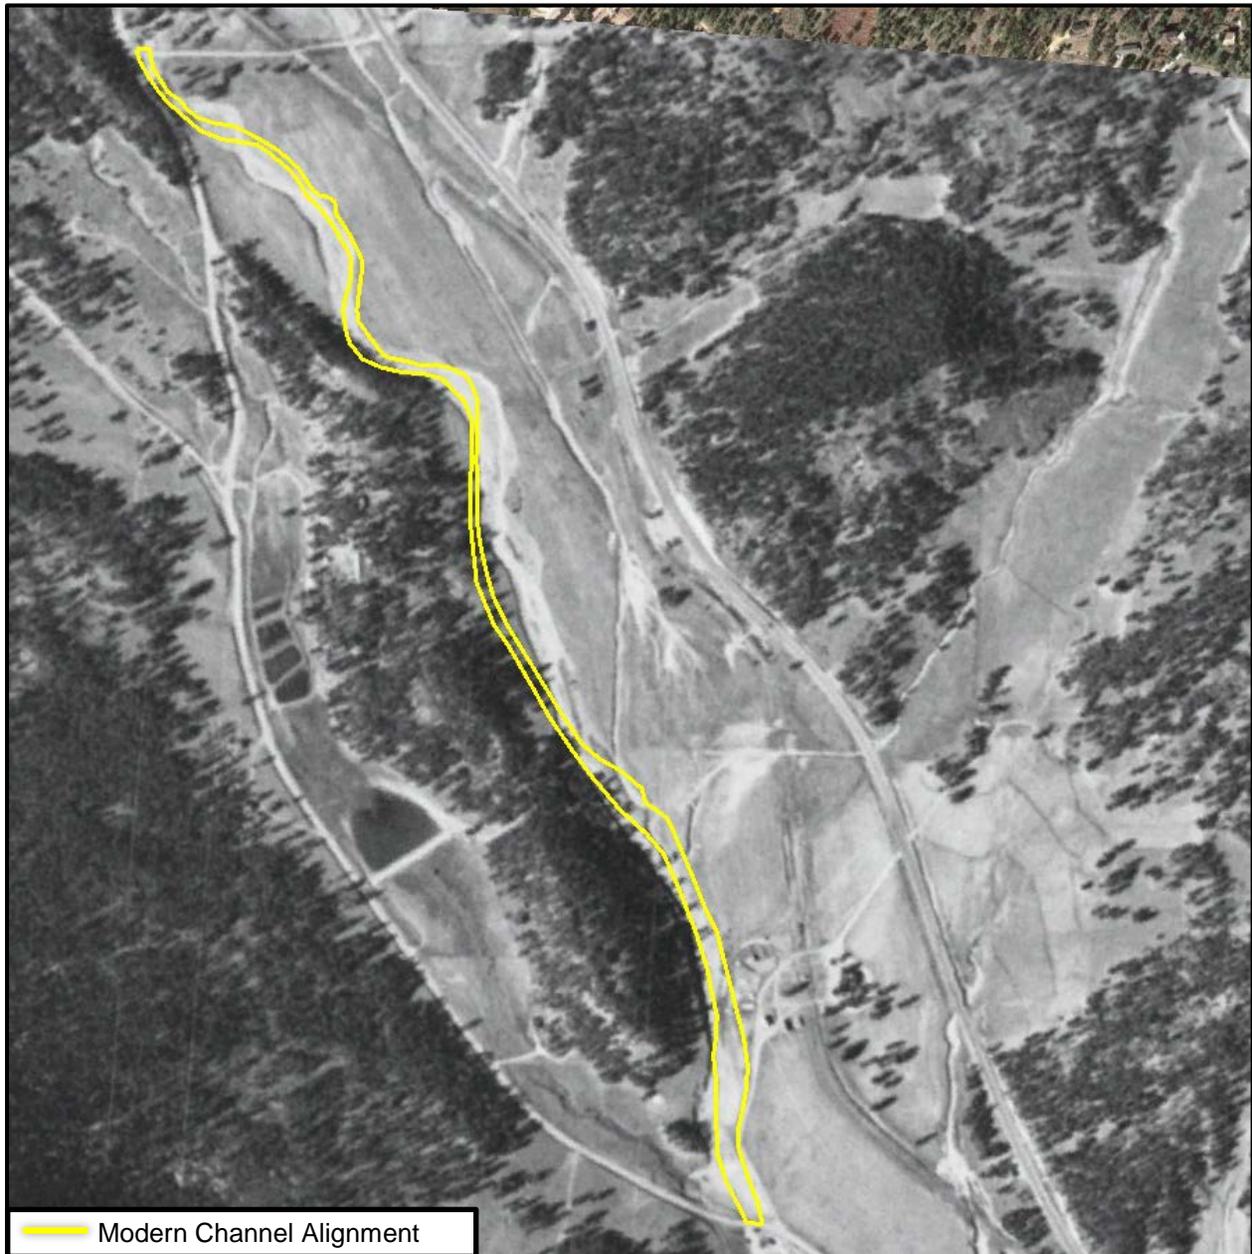
Figure 25 1953 No. 1 of 2

- Small floodplain features on the river-right side in the Saddle Club Reach.
- Main channel not continuously adjacent to in situ sedimentary material on the river-right bank in the Saddle Club Reach, as occurs in modern condition.

- Several minor tributaries join the main channel from the river-left side. The downstream-most tributary joins the main channel downstream of the Study Reach, but the Tributary upstream of this one joins enters the river-left flood plain and appears to bifurcate on the floodplain, forming multiple distributary channel on the floodplain surface. This depositional feature may have been channelized and diverted to the main channel.

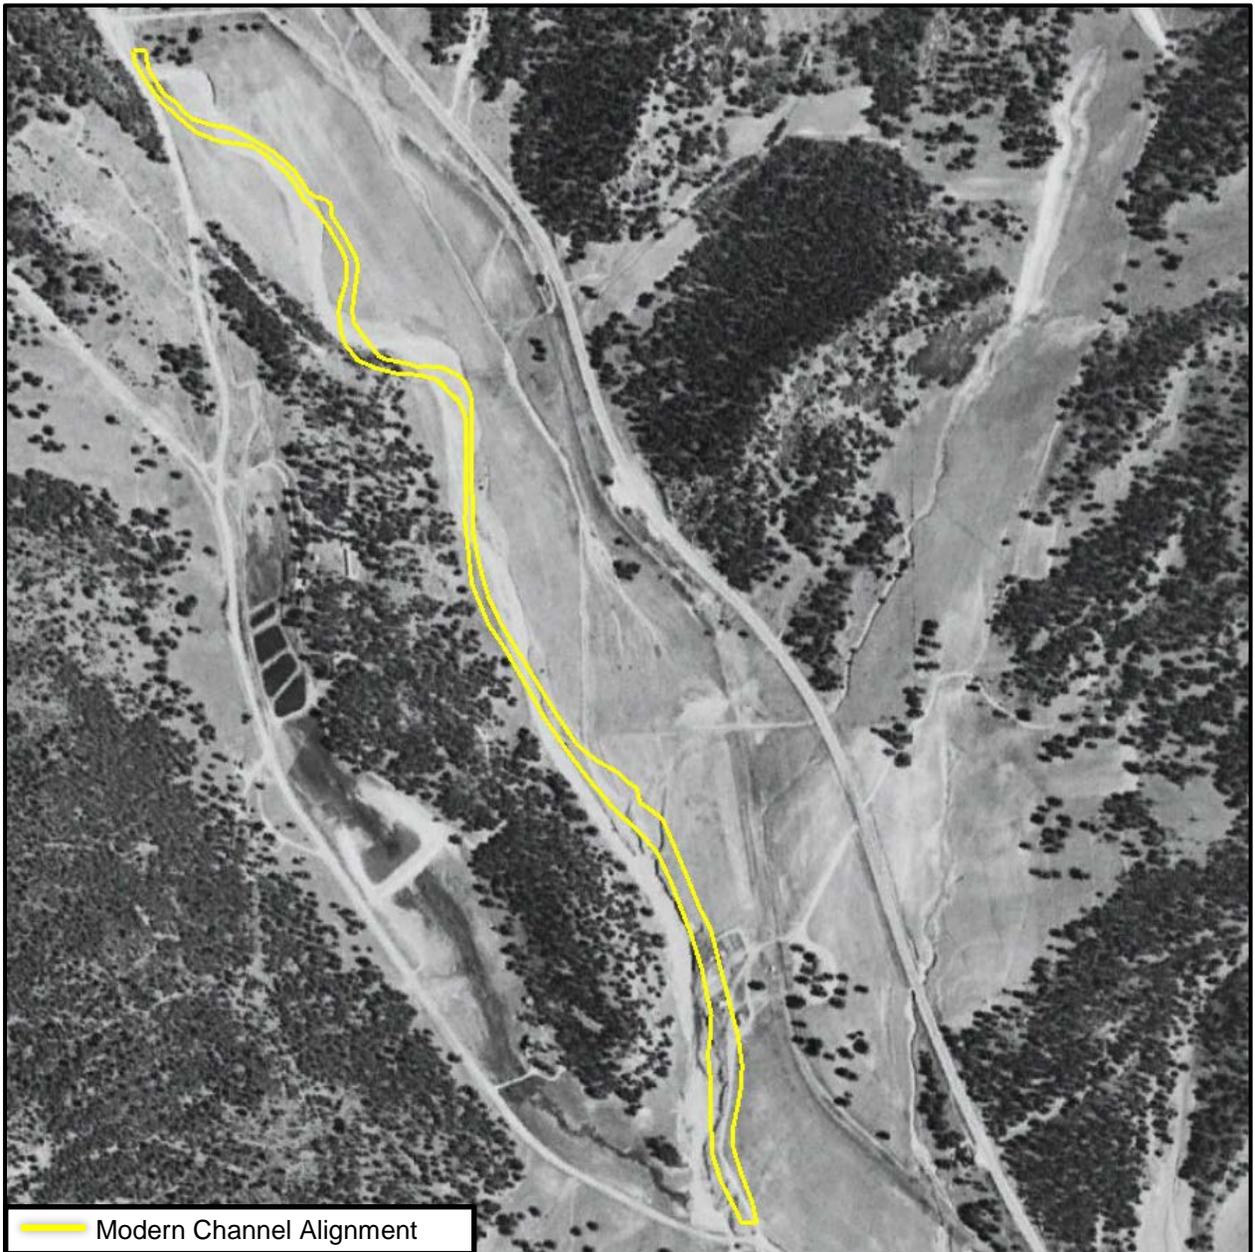
Figure 26 1953 No. 2 of 2

- Note that Figure 26 does not match the modern landscape with sufficient precision to assess landscape change.
- Minimal development of floodplain in the form of buildings in the modern Walmart Reach.

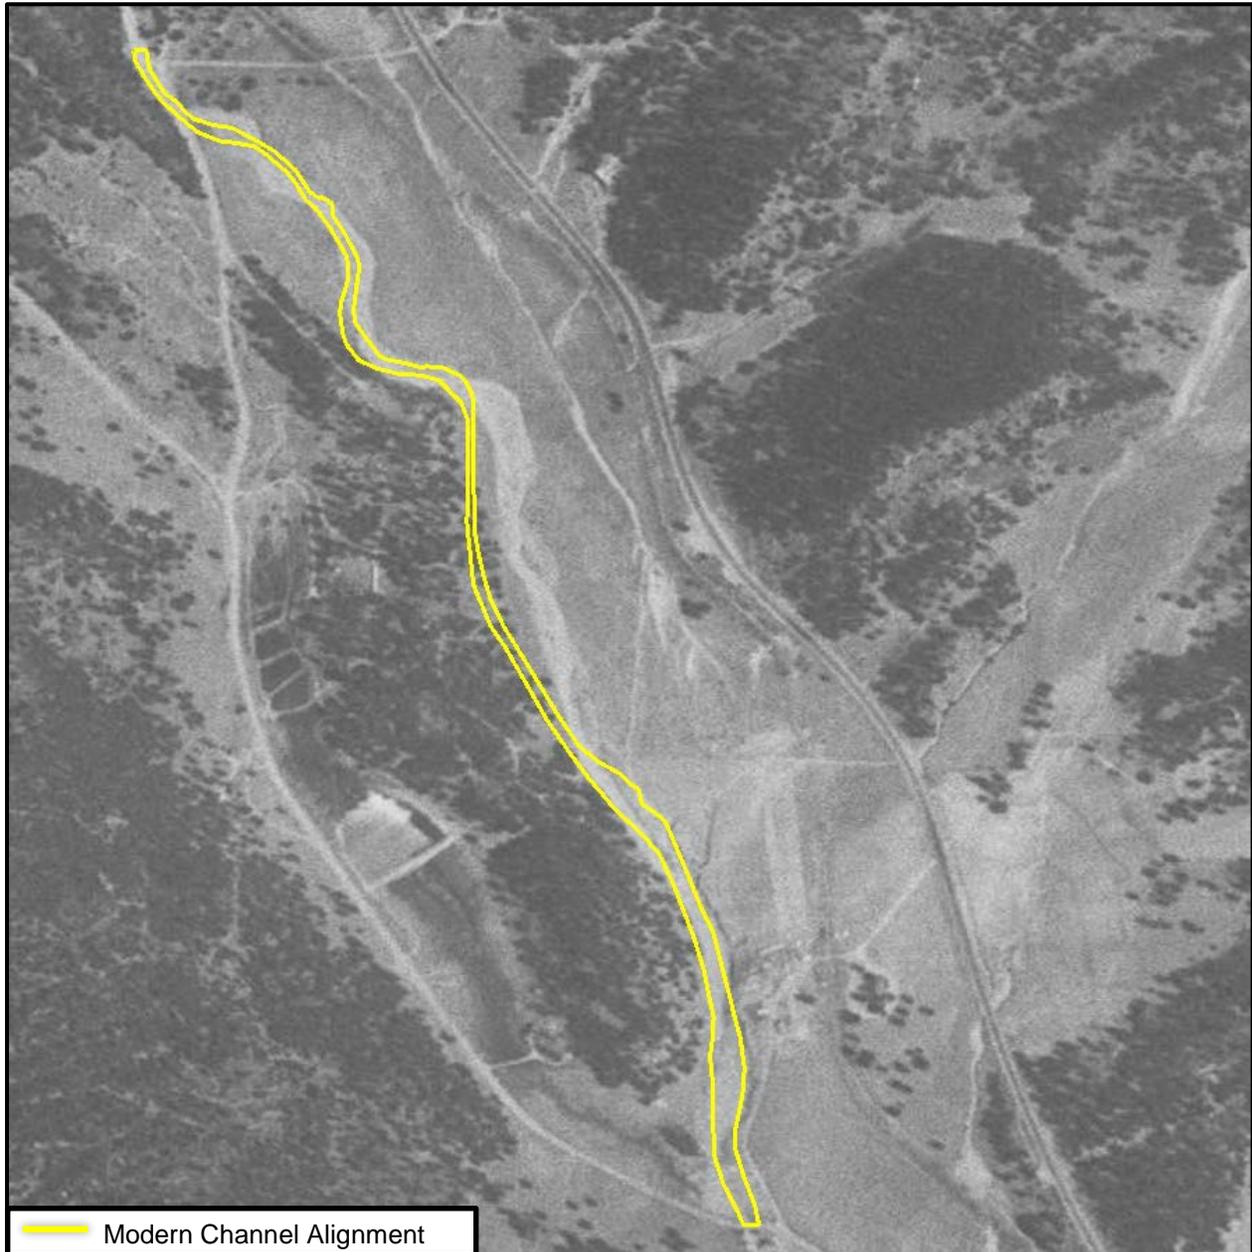
Figure 27 1954

The aerial imagery from 1954 is similar to 1953 with only some channel alignment changes in the Concrete Plant Reach:

- Similar to 1953

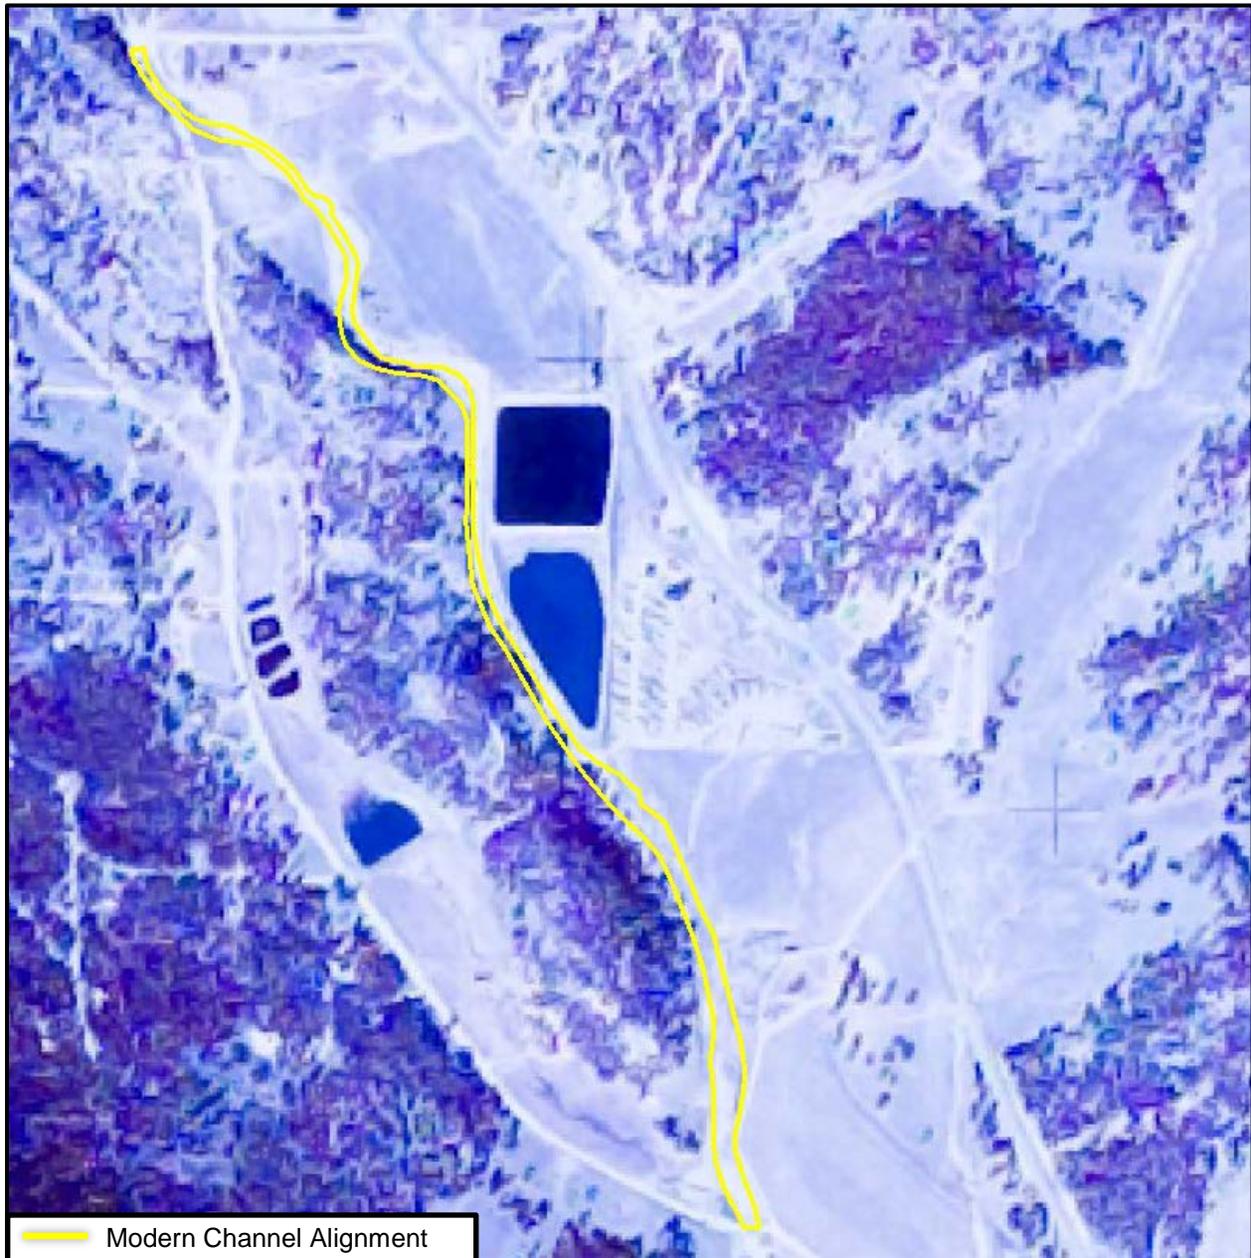
Figure 28 1971

- A reservoir has been constructed in the Saddle Club Reach, consequently narrowing the channel in that reach
- The Concrete Plant has yet to be constructed and the channel in the Concrete Plant Reach is still wide
- Continued development of the river-left floodplain has occurred in the form of a trailer park adjacent to the reservoir and the addition of several buildings at the upstream end of the Study Reach

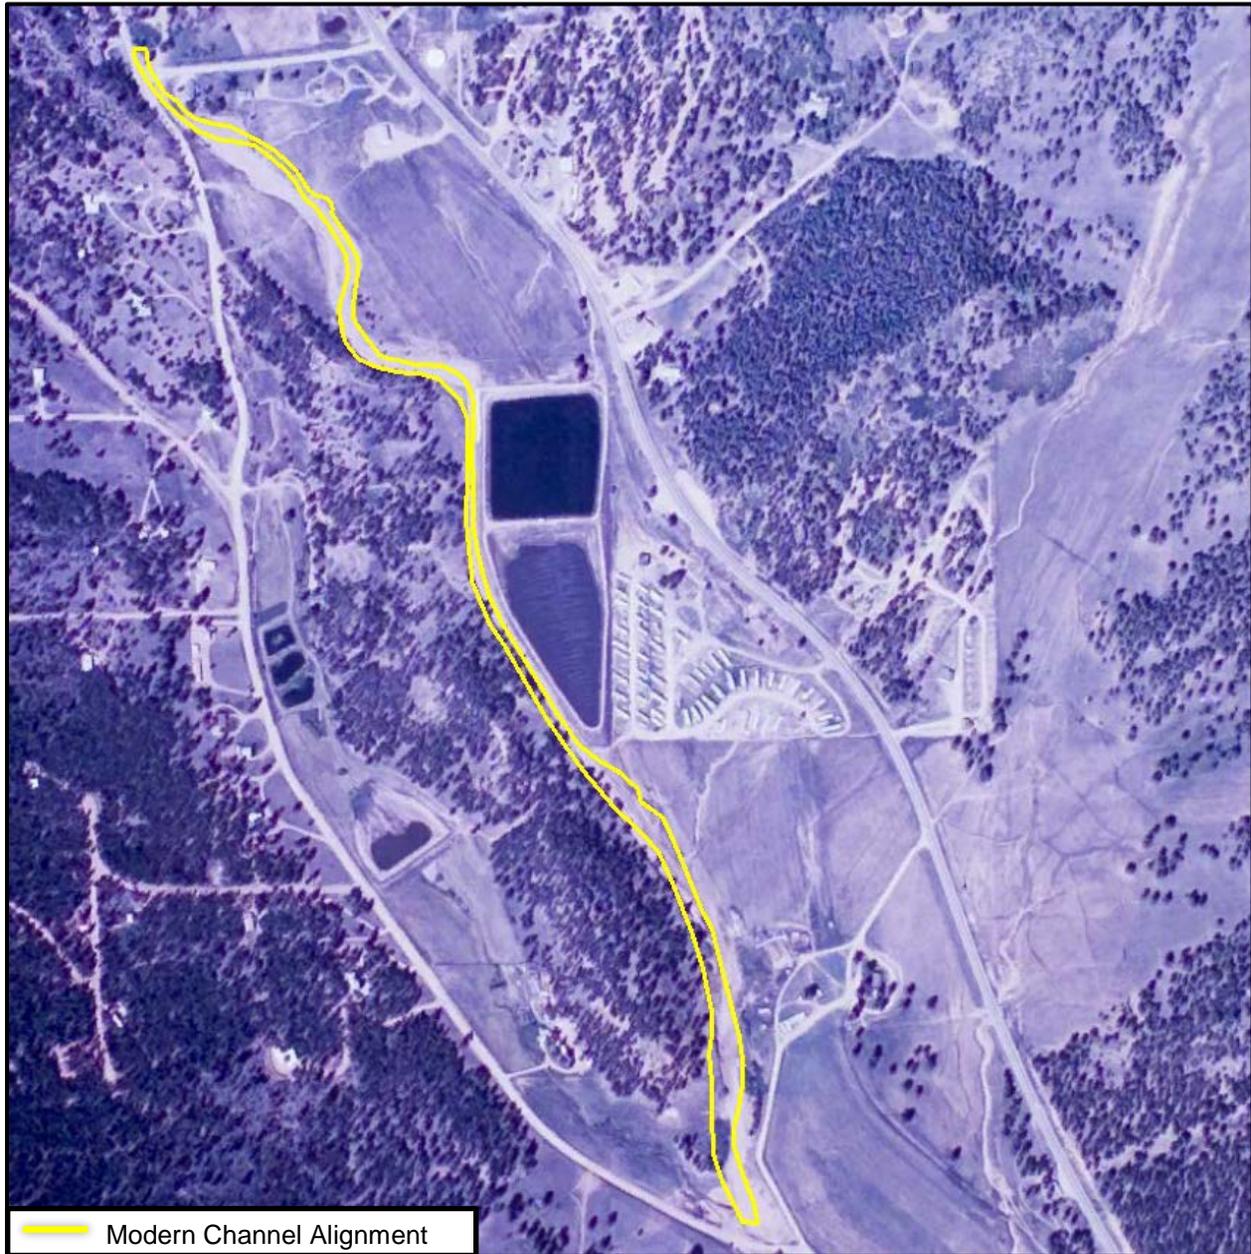
Figure 29 1972

The aerial imagery from 1972 is similar to 1971 with no significant alterations in development and/or overall plan form.

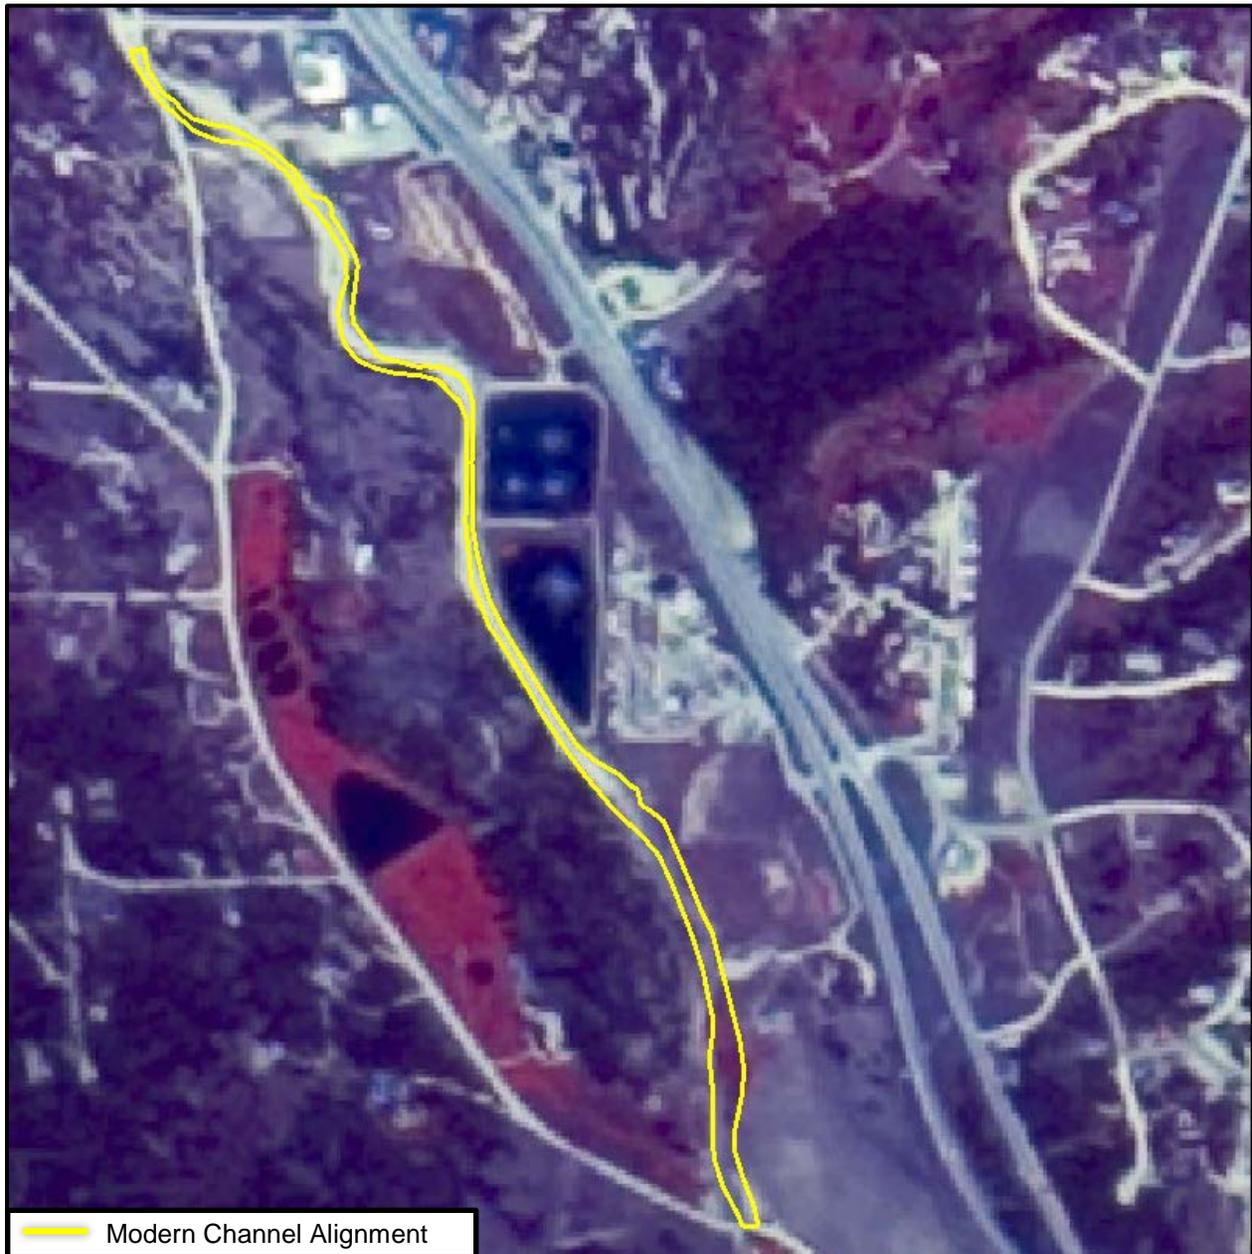
Figure 30 1988

- Low image resolution obscure interpretation
- Continued development of the river-left floodplain
- Possible construction of the Concrete plant
- Channel still wide in Concrete Plant Reach and narrow in Walmart Reach

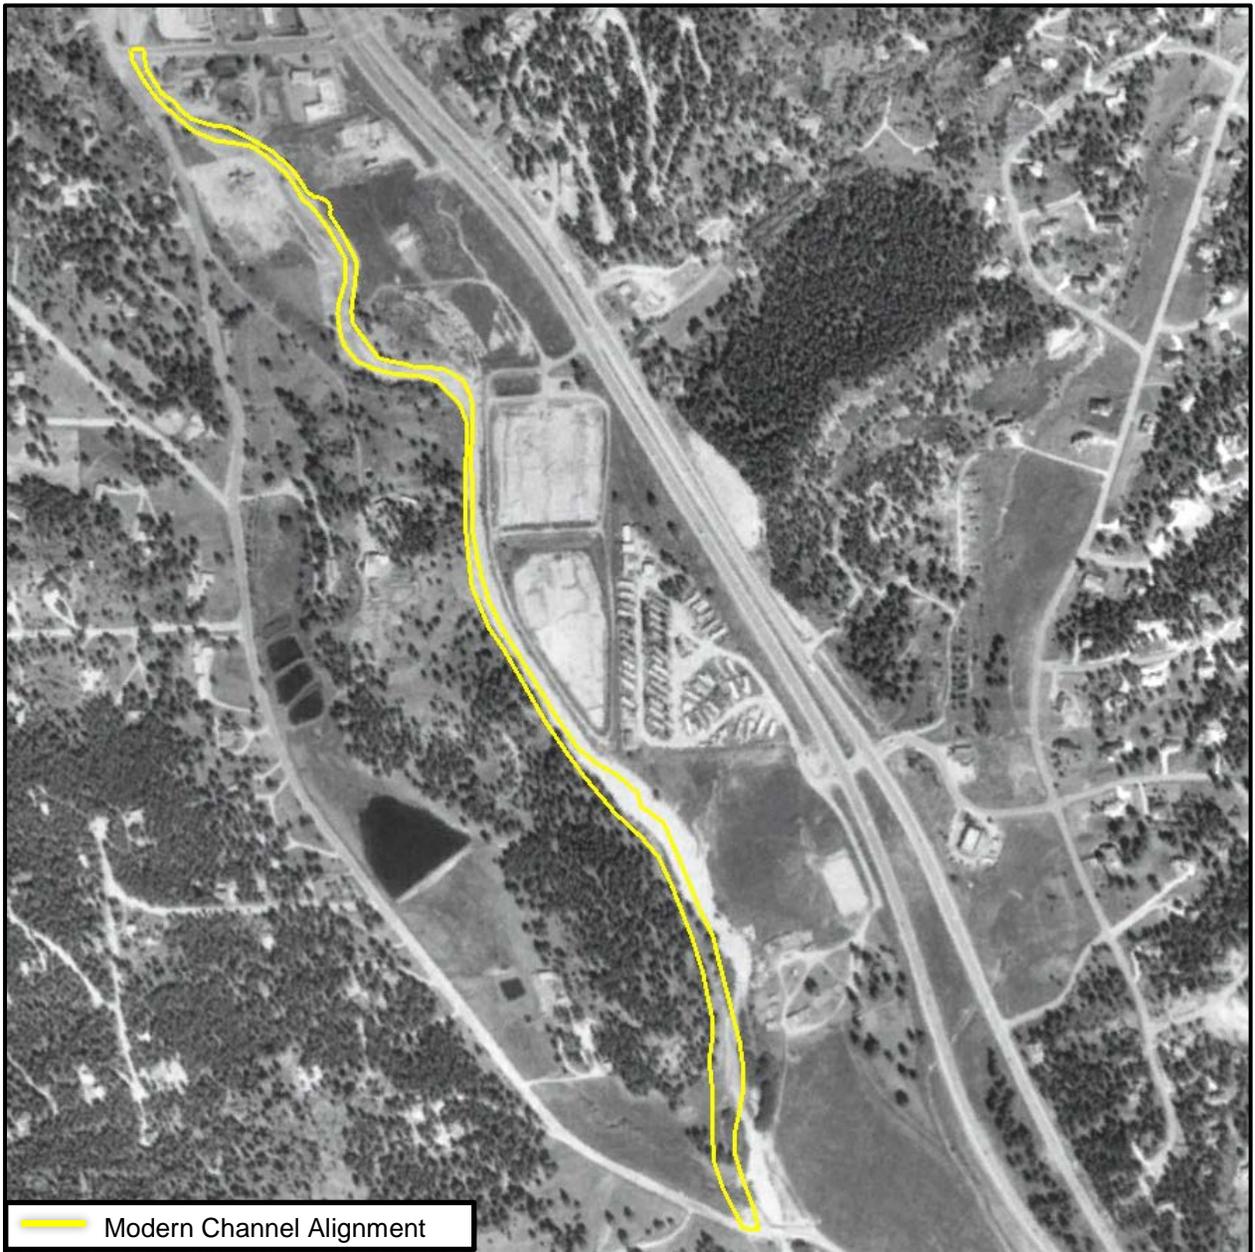
Figure 31 1999

- River-left reservoirs drained
- Concrete Plant encroaches on Concrete Plant Reach channel and constricts channel width
- Continued development of river-left floodplain
- Walmart Reach still has narrow channel

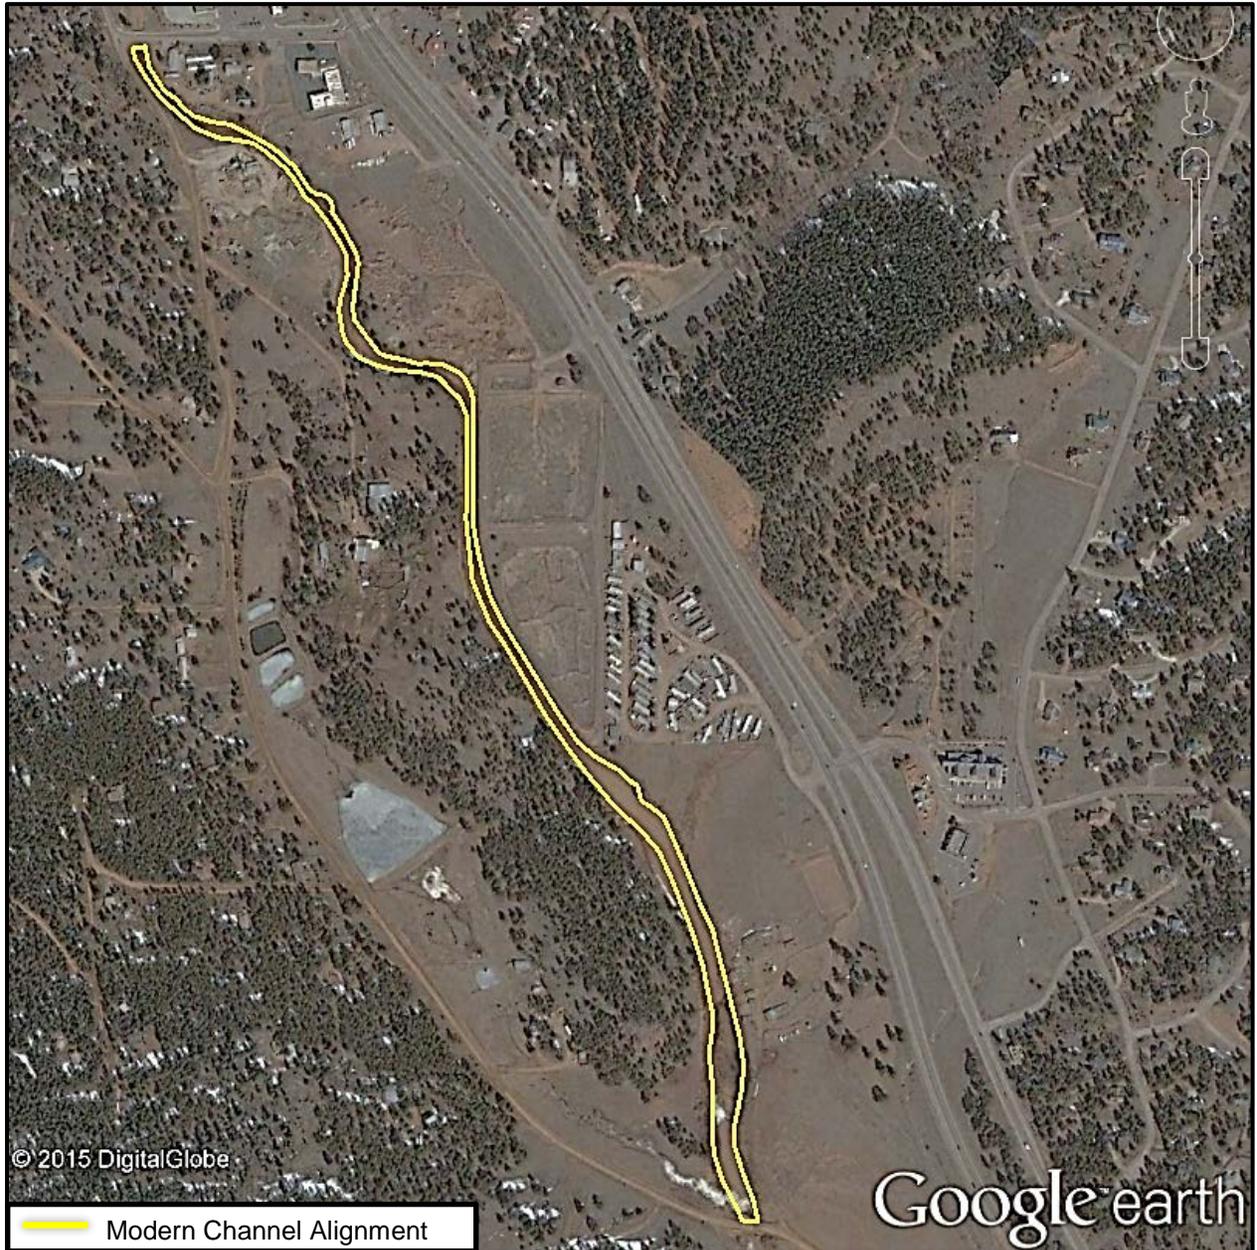
Figure 32 2003

- Concrete Plant and Saddle Club Reaches attain modern morphology, while Walmart Reach remains narrow

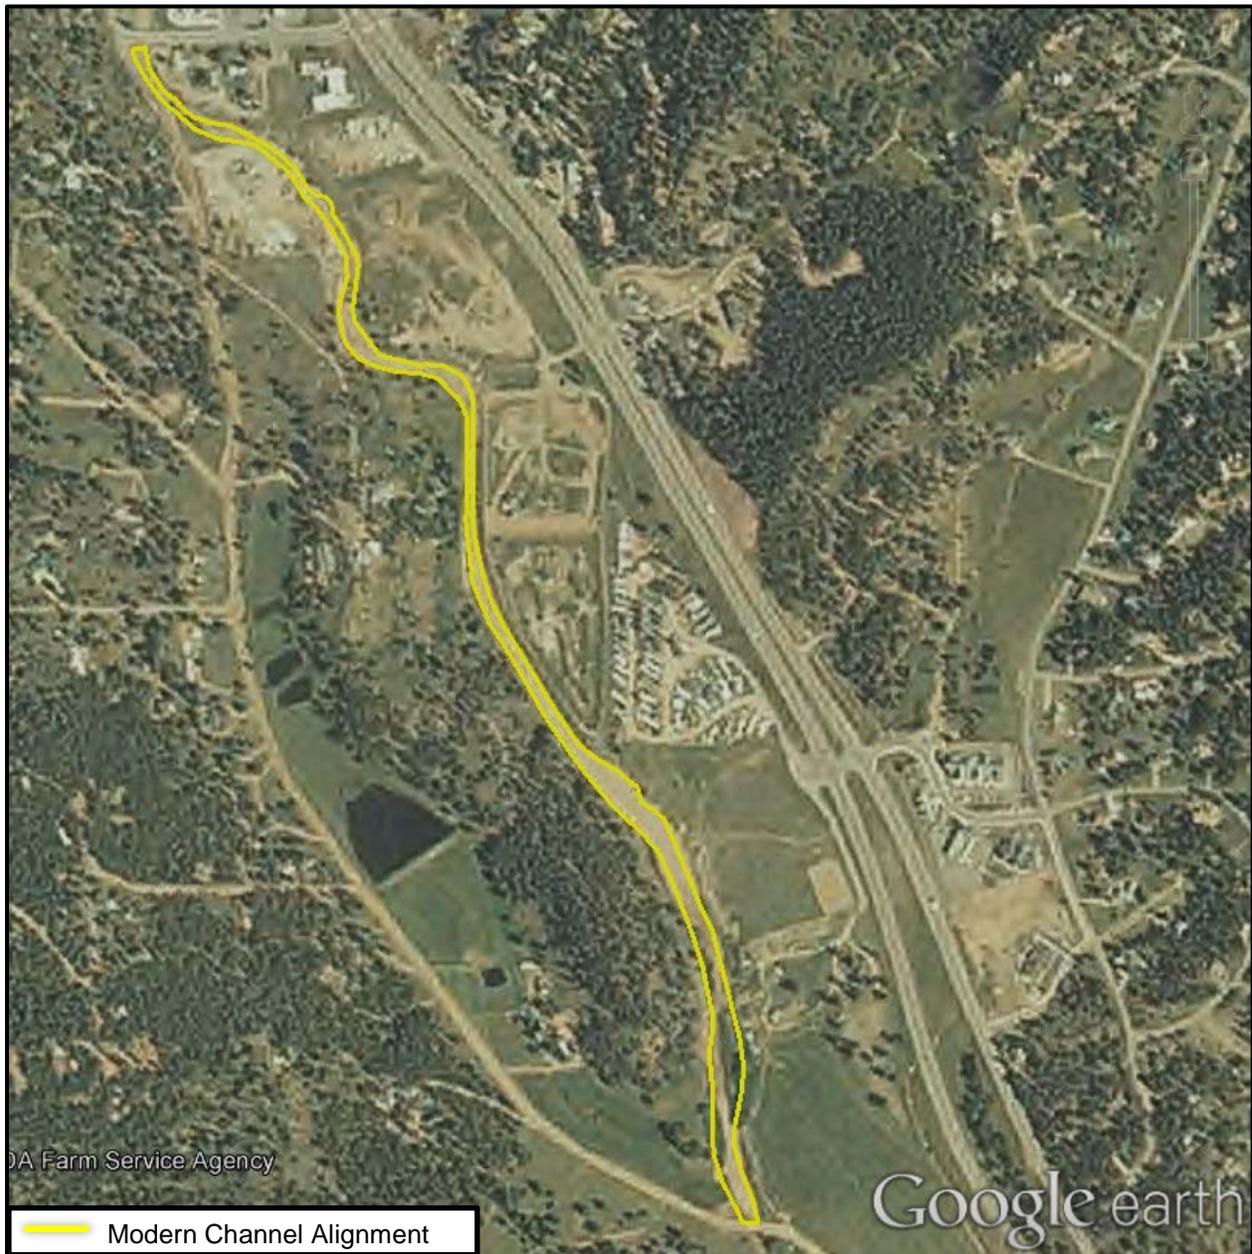
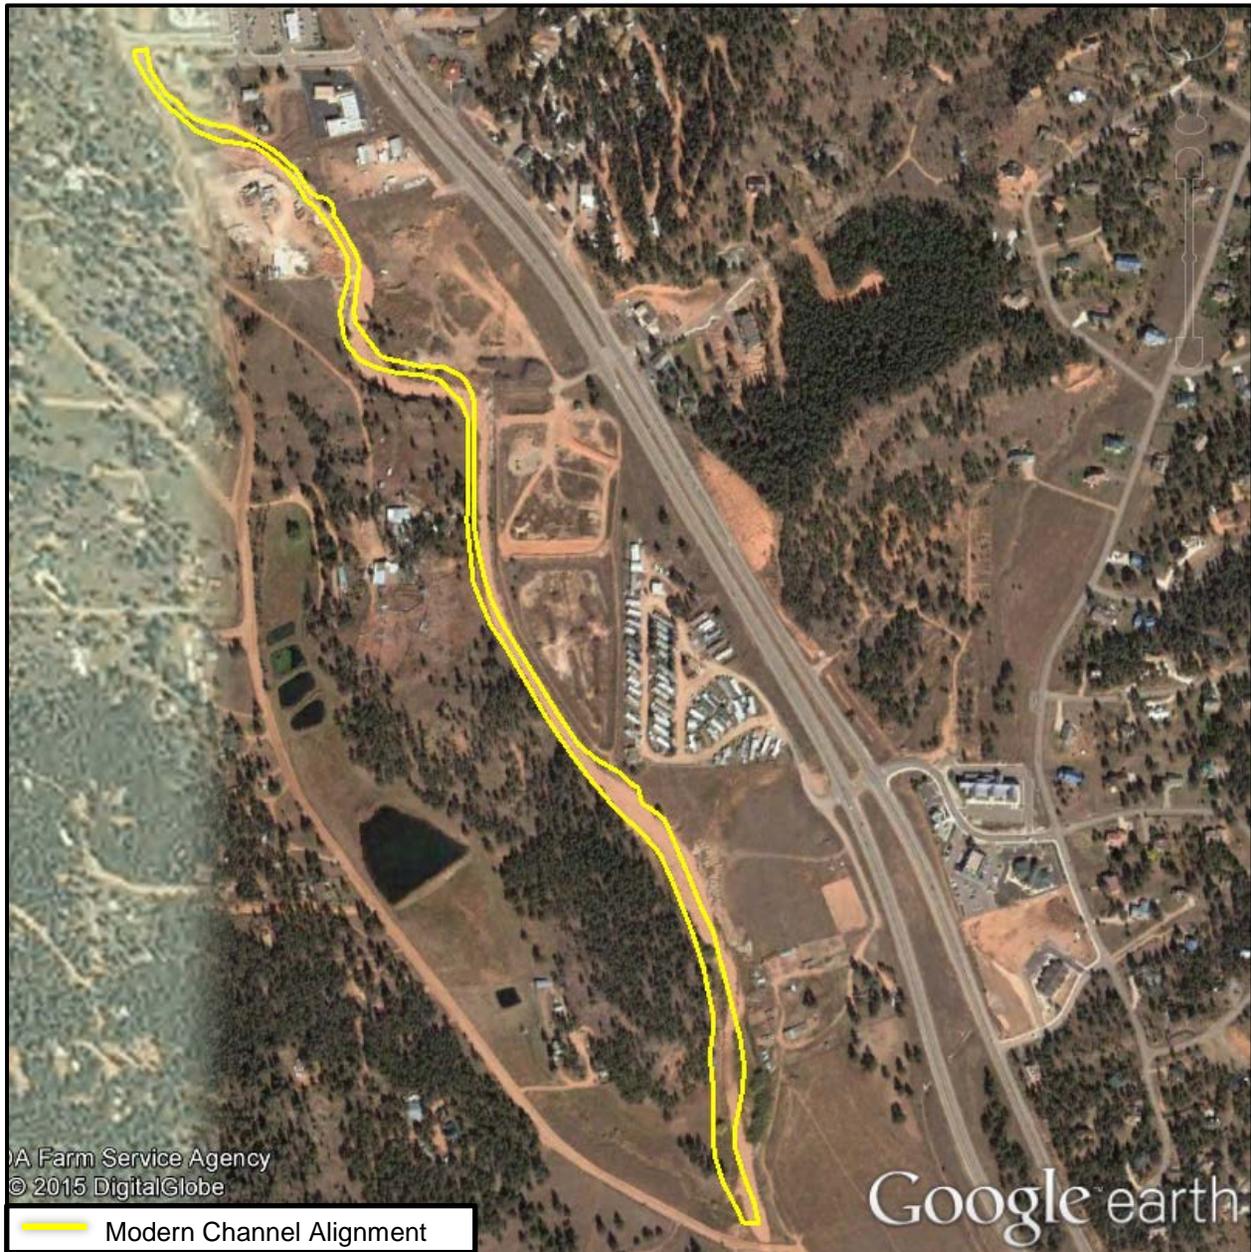
Figure 33 2004

- Similar to 2003
- Concrete Plant and Saddle Club Reaches attain modern morphology, while Walmart Reach remains narrow

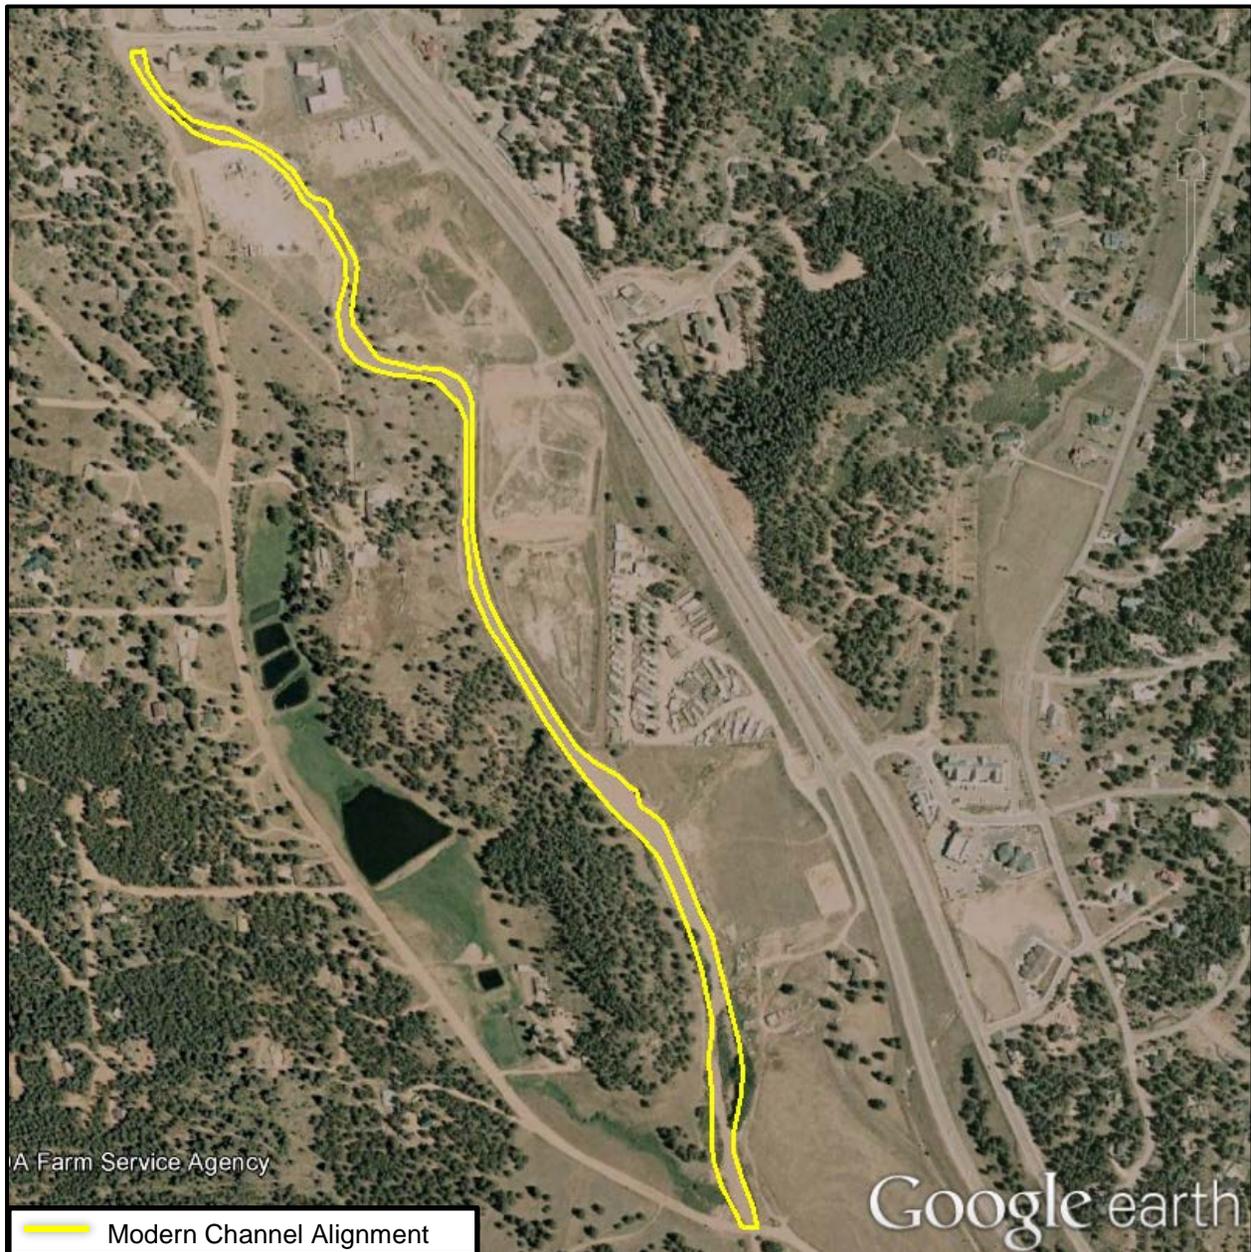
Figure 35 2005

- Similar to 2003 and 2004
- Concrete Plant and Saddle Club Reaches attain modern morphology, while Walmart Reach remains narrow

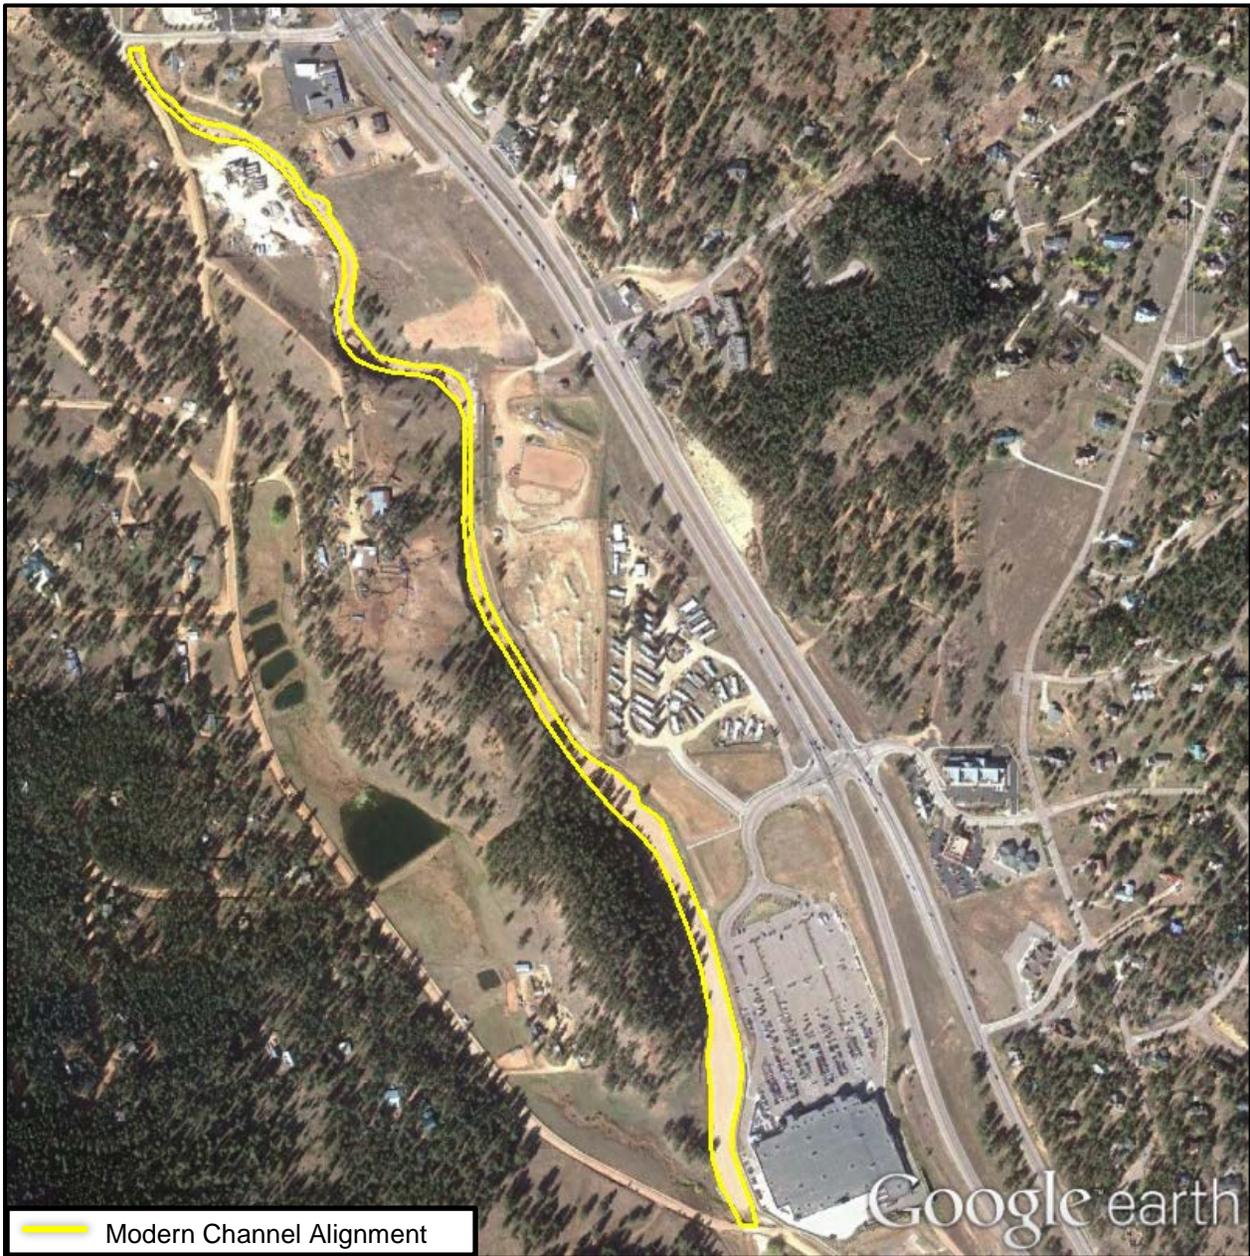
Figure 36 2011

- Channel has attained modern morphology
- The construction of the Walmart shopping center in the downstream portion of the Study Reach has likely resulted in the alteration of the channel banks and the widening of the channel
- Figure 37 and Figure 38 are both from the same source. Figure 37 includes overlays of other geographic information, including the source of the spring that feeds Spring Creek
