GEOMORPHIC ASSESSMENT

**Fountain Creek in Woodland Park between
Aspen Garden Road and Crystola Road**

Submitted By: Golder Associates Inc.
44 Union Boulevard, Suite 300
Lakewood, Colorado 80228

June 29, 2015

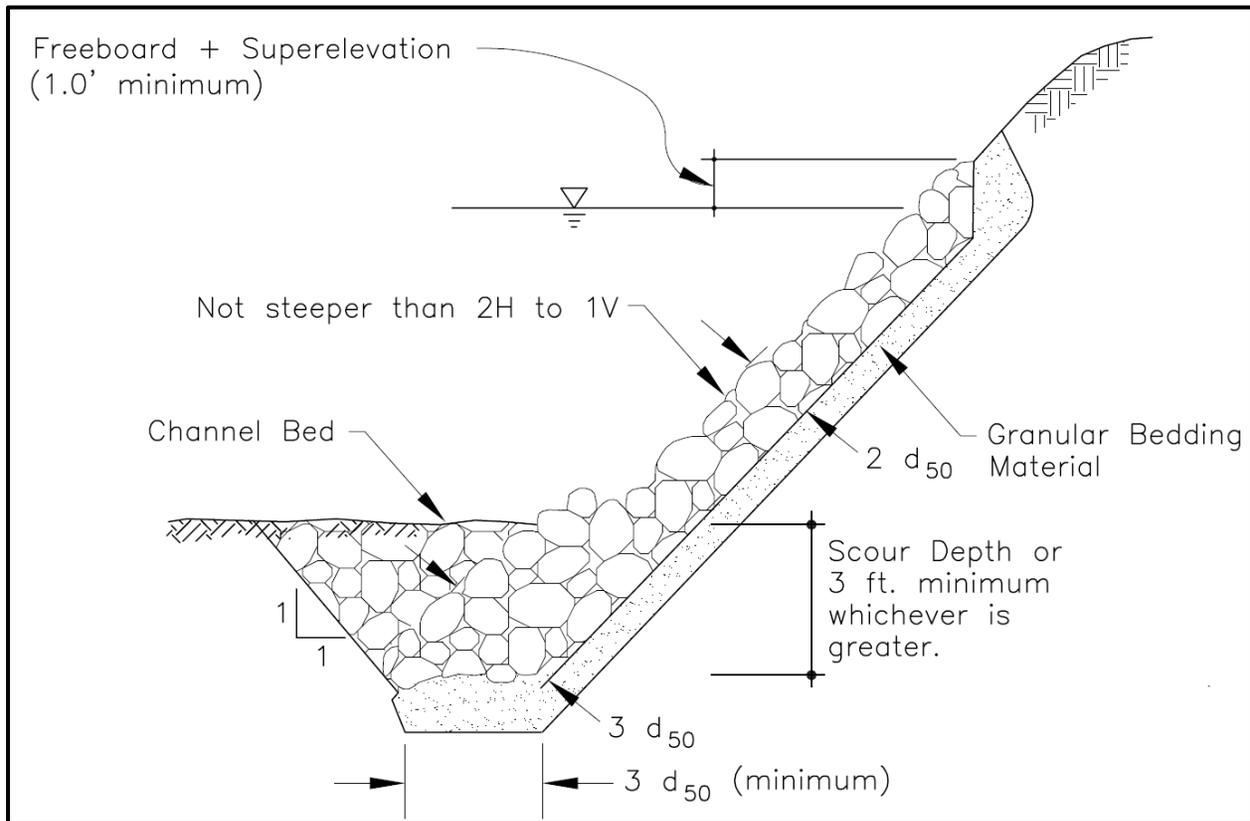
Figure 50 Sketch of Proposed Riprapped Bank Protection

For most of Study Reach from Aspen Garden Bridge to the top of the Walmart Reach, the banks and especially the toe of the banks have been lined with un-designed revetment material. This intention in placing this material was undoubtedly to protect the banks of the channel from further erosion. The material consists of construction debris, waste rock, left over concrete, old tires, car bodies, and an assortment of other items. While well intentioned, the placement of these materials in a haphazard fashion has resulted in insufficient erosion protection and a public eyesore. Golder recommends the complete removal and redesign of all of the bank protection and erosion revetment present between Aspen Garden Bridge and the downstream end of the Saddle Club Reach.

While in most river restoration plans vegetation is incorporated into the remediation plan to enhance stabilization efforts and aesthetics, the arid environment and the intermittent water regime make relying on vegetation as an erosion prevention mechanism impossible. To compensate for the lack of applicable bioremediation techniques, Golder proposes to implement standard bank protection measures in the form of a riprapped bank (Figure 50).
